105 Wimbleton Road, Toronto, Ontario

SUMMARY INSPECTION REPORT

INSPECTION REPORT

PROPERTY: 105 Wimbledon Road, Toronto, Ontario

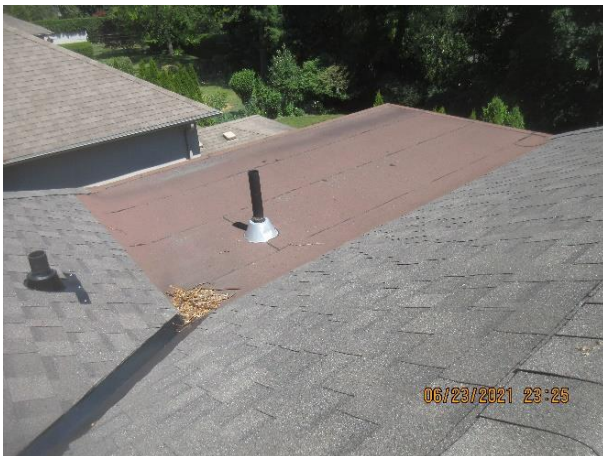
2.03A Asphalt roofing shingles: Typically, this type of roofing material will last 20 years. All flashing around roof projections should be checked periodically to ensure there is a watertight seal. Slopes that face south and west receive more sunlight and generally wear faster. The asphalt shingles are in very good condition and were upgraded within the last year. There is one layer of asphalt shingles present on all sides.

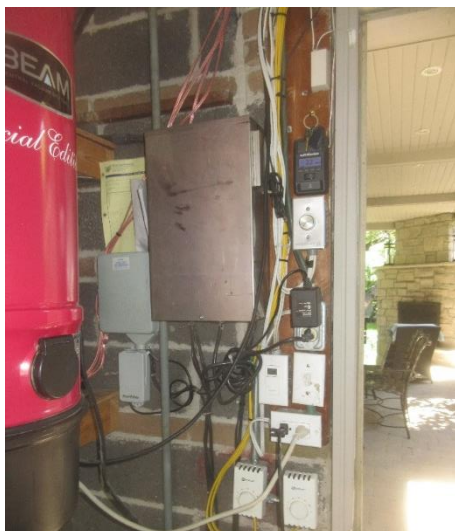
2.11B Concrete decks: The paving stone porch/deck at the front is intact. The support columns for the front porch roof are secure. The roof structure appears sound. The rear porch structure is a recent build and is in good condition. The support columns for the rear porch roof are also secure. The roof structure is sound. Wood finishes are well painted. There are electric heating units mounted below the ceiling. The heating elements were not operated.

G: there are several switches and timers adjacent to the rear garage entry door. These were not operated. Their purpose and function should be discussed with the owner prior to closing.

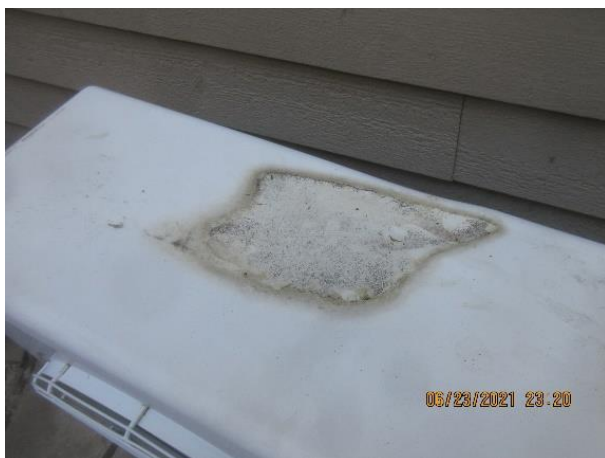
4.03E Split Coil Air-conditioning: An air-cooled, 'ductless' air-conditioning system is present on the 2nd floor (work-out room). The equipment was installed about 20 years ago and is equipped with a natural gas heater for winter use.

G: there is some heat damage to the casing of the exterior unit due to the natural gas heater contained within the system. The equipment should be serviced to ensure that the heating component is operating correctly. The system was not operated in heat mode as the air-conditioning component was in use. Eventual upgrade of this equipment will be required.

(Budget \$5,000)

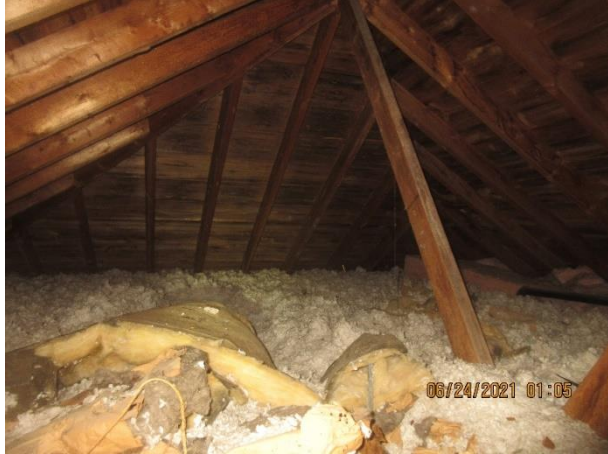
6.01A Attic: There are about 10-12 inches of rock wool and fiberglass batt insulation present in the attic. This amount of insulation corresponds to a thermal resistance value of R-32. This is enough to minimize heat loss through the ceiling.

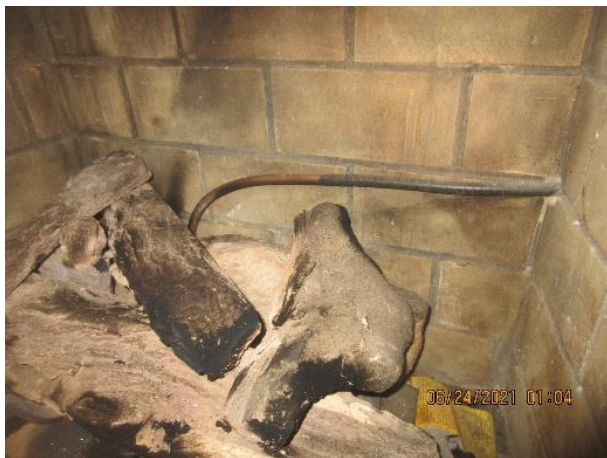
7.04F Natural gas fireplace: A gas-fired, log burning fireplace insert has been installed in the original wood burning fireplace in the living room. The primary drawback to these units is the requirement that the damper be secured in an open position, thereby resulting in unnecessary heat/cool loss when not in use. If the unit is not used regularly, then the damper should be closed. This should be done in any event during the summer months. The fireplace was operated and found to be functioning properly. Annual servicing and cleaning is advisable to ensure safe operation.

G: there is a copper gas pipe at the rear of the living room fireplace. Its proximity to the flame is of concern. A licensed gas pipefitter should examine the installation to ensure that clearances between the pipe and the ceramic log insert are sufficient.
