52 Sunnydene Crescent, Toronto, Ontario

SUMMARY INSPECTION REPORT

INSPECTION REPORT

PROPERTY: 52 Sunnydene Crescent, Toronto, Ontario

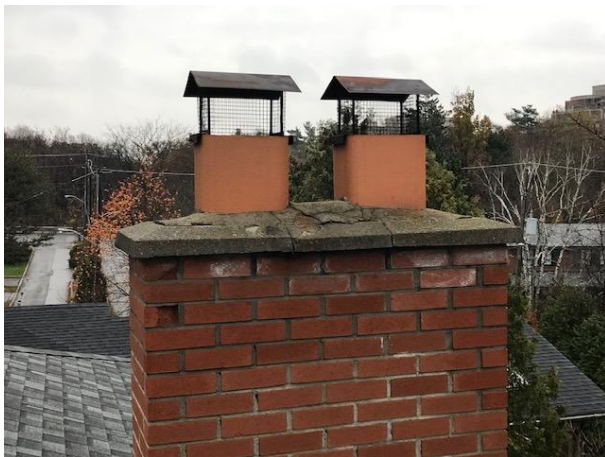
G: a couple of bricks on the fireplace chimney have lost their protective outer facing, exposing the soft inner core of the brick to the elements (known as spalling). The damaged bricks should be replaced. Repair loose concrete finish on the cap.

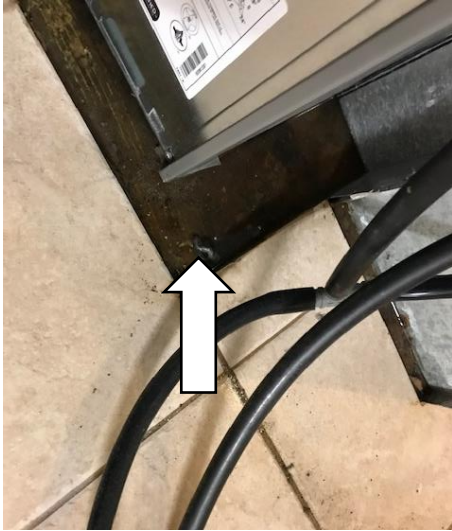
P: there is standing water at the base of the furnace and near the floor drain. The source of moisture could not be determined (most likely be furnace equipment). The furnace should be serviced. The moisture does not appear to have originated from the foundation.

P: as discussed previously, there is water sitting around the base of the furnace. A service call is required to determine whether the water originates from the furnace and repaired necessary.

Seller is repairing furnace, will include copy of invoice once repaired
