120 Carrington Drive, Richmond Hill, Ontario

SUMMARY INSPECTION REPORT

INSPECTION REPORT

PROPERTY: 120 Carrington Drive, Richmond Hill, Ontario

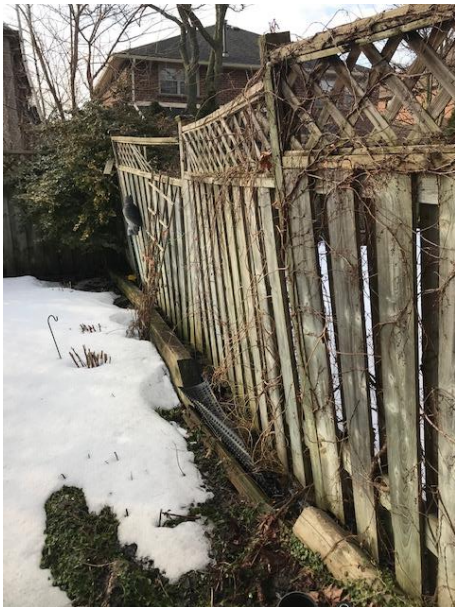
G: the rear fence is failing and should be replaced.

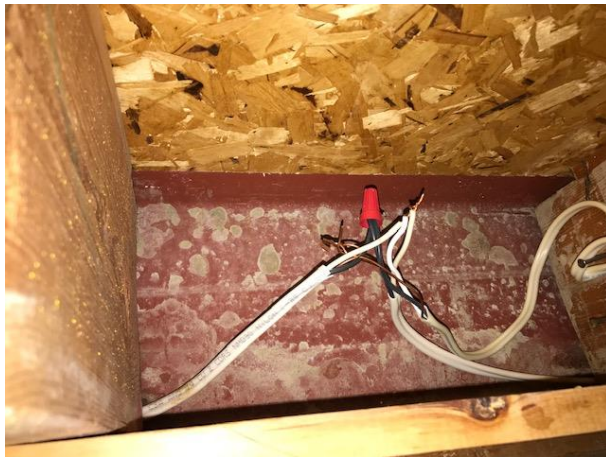
P: unprotected wiring connections are visible in the two locations in the basement ceiling. One is located near the steel I-beam in the NW basement utility room. The other is located on the doorframe opposite the furnace. The wires should be reinstalled in a junction box to prevent them from becoming loose.
