60 Fenley Drive, Toronto, Ontario

## **SUMMARY INSPECTION REPORT**

## INSPECTION REPORT

PROPERTY: 60 Fenley Drive, Toronto, Ontario

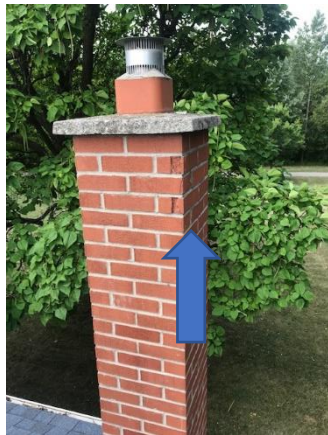
2.07A Brick Chimneys: The brick chimney on the west side contains one flue and it vents the water heater. The water heater flue is equipped with a continuous metal liner which is beneficial to prevent deterioration of the chimney and ensure a proper draft in the flue.

*G: at least two bricks have lost their protective outer facing, exposing the soft inner core of the brick to the elements (known as spalling). A couple of others are cracked. The damaged bricks should be replaced. (Approximate Cost: \$500 to \$800)*
