4 Marquis Avenue, Toronto, Ontario

SUMMARY INSPECTION REPORT

INSPECTION REPORT

PROPERTY: 4 Marquis Avenue, Toronto, Ontario

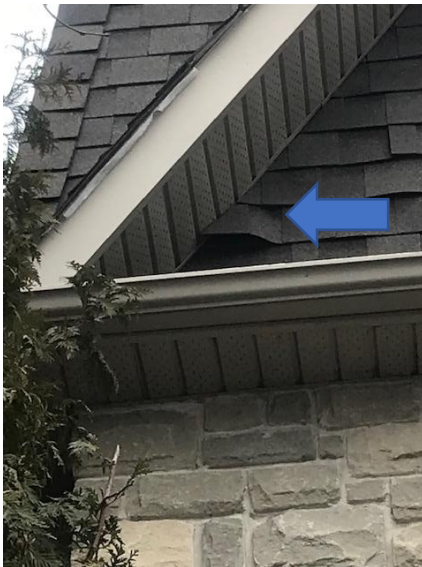
2.03A Asphalt roofing shingles: Typically, this type of roofing material will last 20 years. All flashing around roof projections should be checked periodically to ensure there is a watertight seal. Slopes that face south and west receive more sunlight and generally wear faster. The asphalt shingles above the attic could not be inspected to a lack of access. It would appear that the roof shingles above the attic have been recently replaced. Those shingles below the roof structure (known as a mansard roof) were replaced on the north and south sides of the house. Those shingles on the mansard roof structure on the remaining two sides are original. They appear to have several years of life remaining.

G: secure lifted shingle on front gable at southwest corner. As well, there is a shingle that has loosened at the northeast corner on the mansard roof- below the upper roof structure.

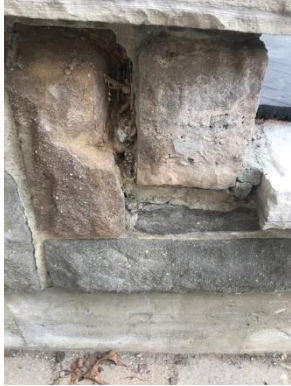
2.11B Concrete decks: The front concrete stoop is in good structural condition. The concrete steps are intact and metal rails are secure. The flagstone facing on the deck surface and steps is secure. The stonework is intact.

G: there is localized mortar loss between stones on the front deck that should be repaired.

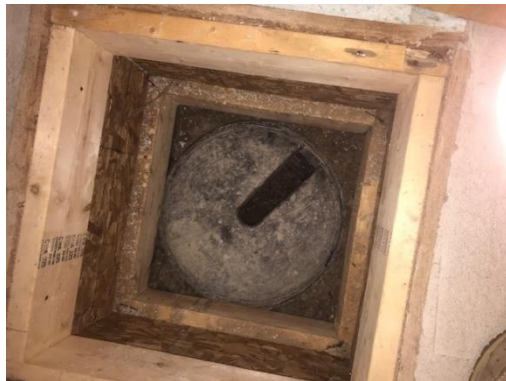
M: there is a sump pit in the basement floor near the electrical panel. These are typically installed to deal with foundation waterproofing systems. As the basement is located at or above grade, the need for foundation waterproofing would not have been required. The pit in the floor has some groundwater present, as would be expected. There is no sump pump present. There is no evidence that water has breached the pit and so long as this continues, a pump would not be required.
