147 Royalavon Crescent, Toronto, Ontario

## **SUMMARY INSPECTION REPORT**

## INSPECTION REPORT

PROPERTY: 147 Royalavon Crescent, Toronto, Ontario

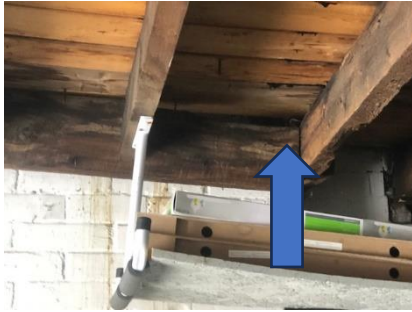
*P: the garage roof requires localized re-supporting in one location.*
