2 Allanbrooke Drive, Toronto, Ontario

## **SUMMARY INSPECTION REPORT**

## INSPECTION REPORT

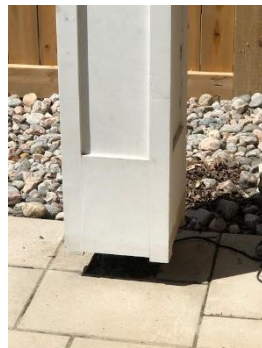
*P: the ceiling/trim of the west porch overhang requires paint. The wood columns are capped with wood and some of the wood finishing that borders the posts at grade is poorly done/incomplete.*
