134 Wareside Road, Toronto, Ontario

SUMMARY INSPECTION REPORT

INSPECTION REPORT

PROPERTY: 134 Wareside Road, Toronto, Ontario

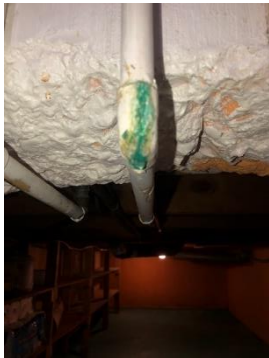
G: There is a small leak at a pipe fitting near the laundry facilities. The elbow is located directly above the access area to the crawl space.
