YOUR Inspection Report

3304 Stalybridge Drive
Oakville, ON L6M 0K8

Wednesday, September 17, 2025

Report No. 9156

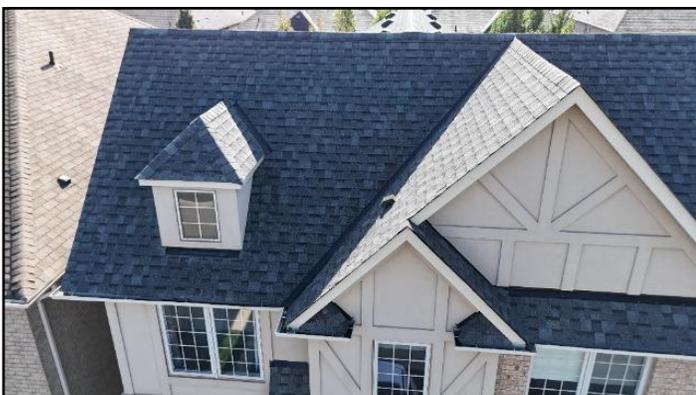
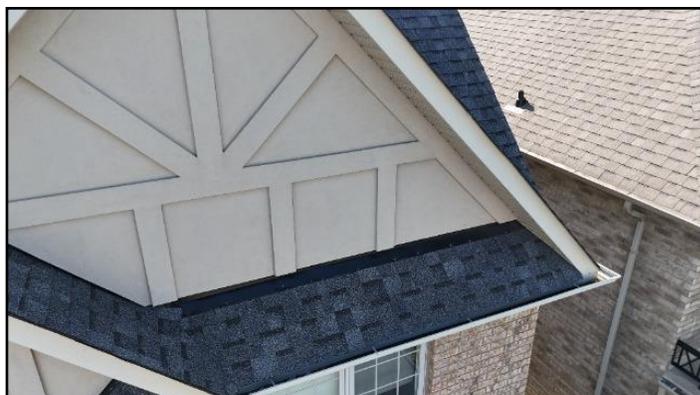
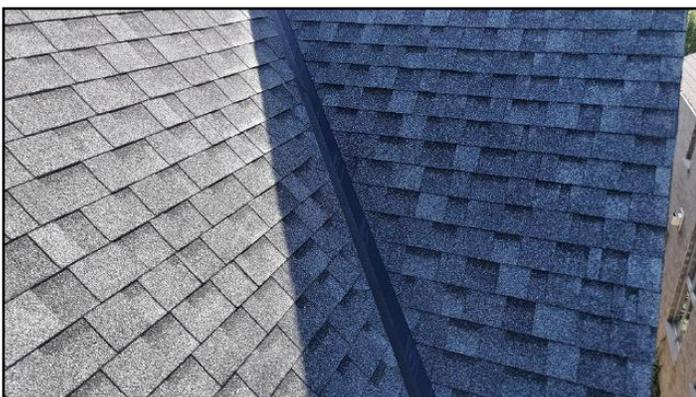
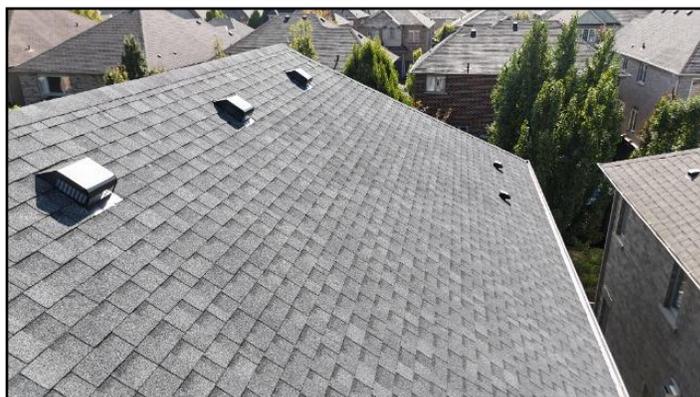
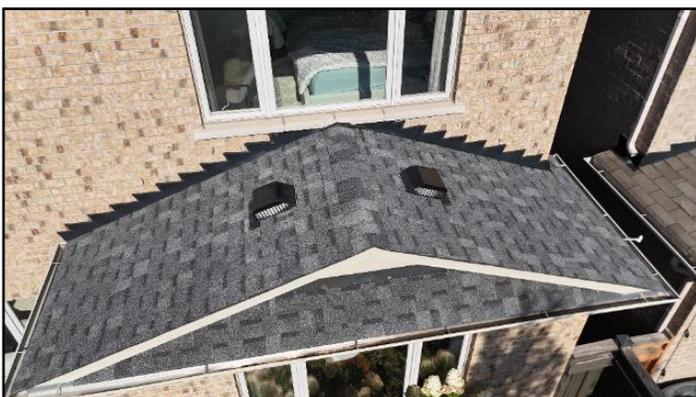
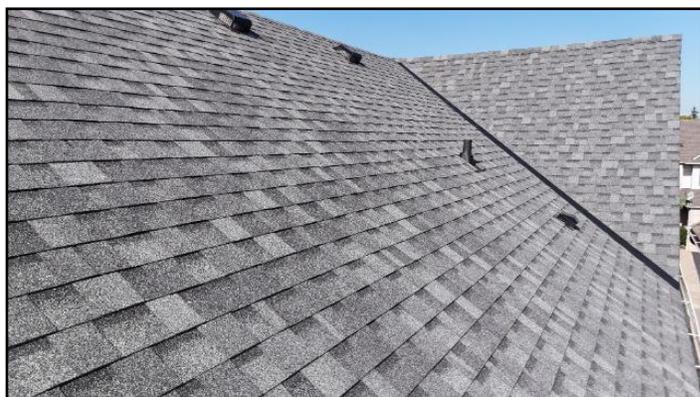
Condition: • View of roof from above:

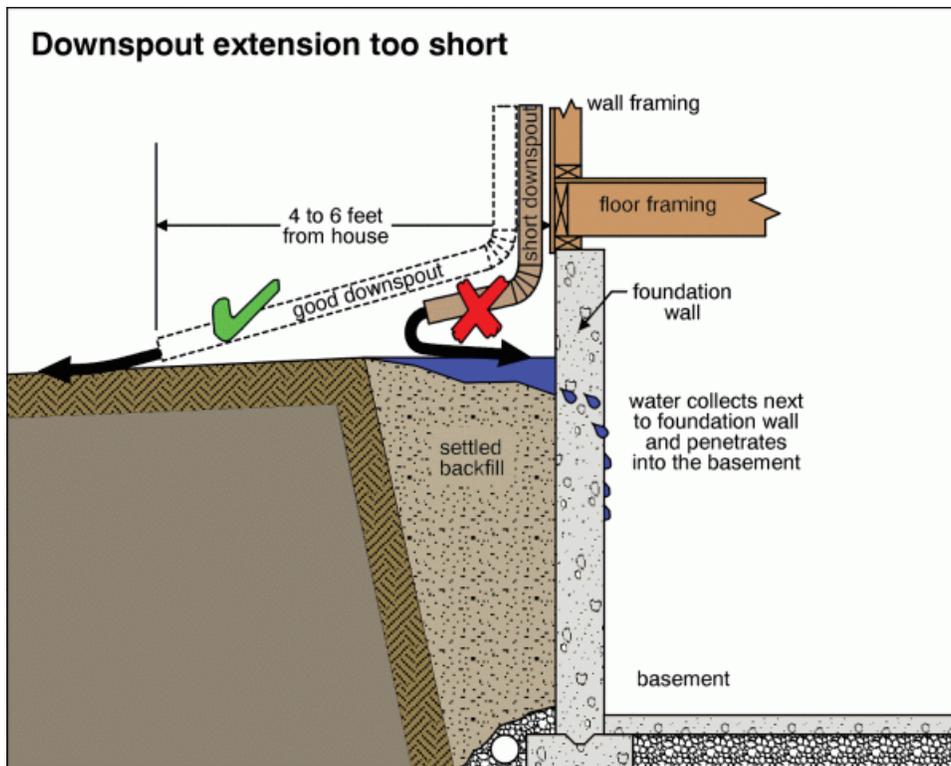
Condition: • [Downspout ends too close to home. It should direct water at least 6 feet from building.](#)

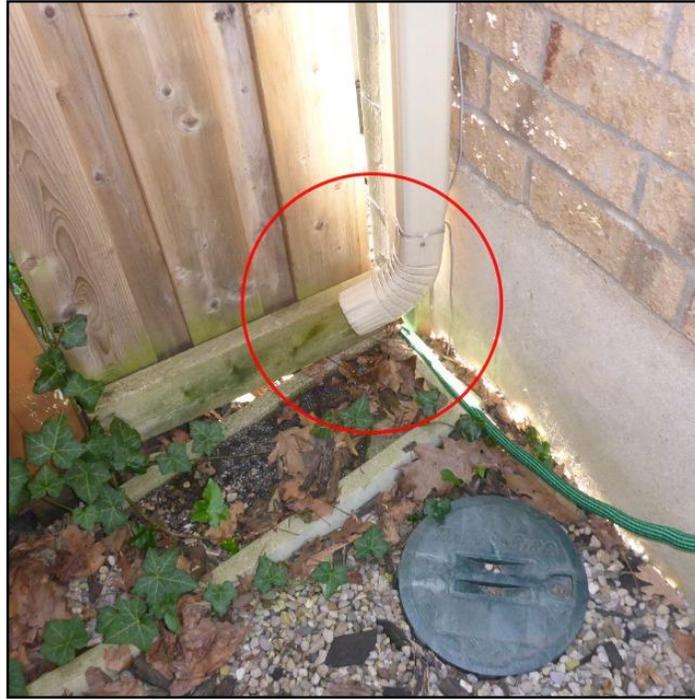
Extend downspouts away from foundation

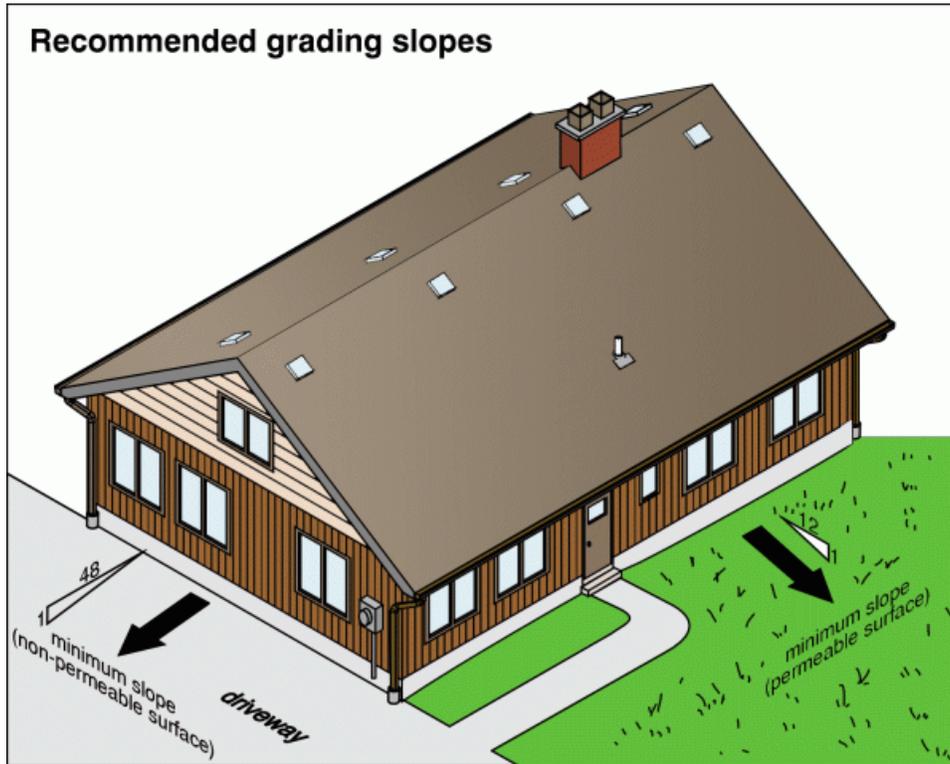
Condition: • Low areas

To reduce the likelihood of water penetration to the basement, always maintain a positive slope away from the foundation wall.

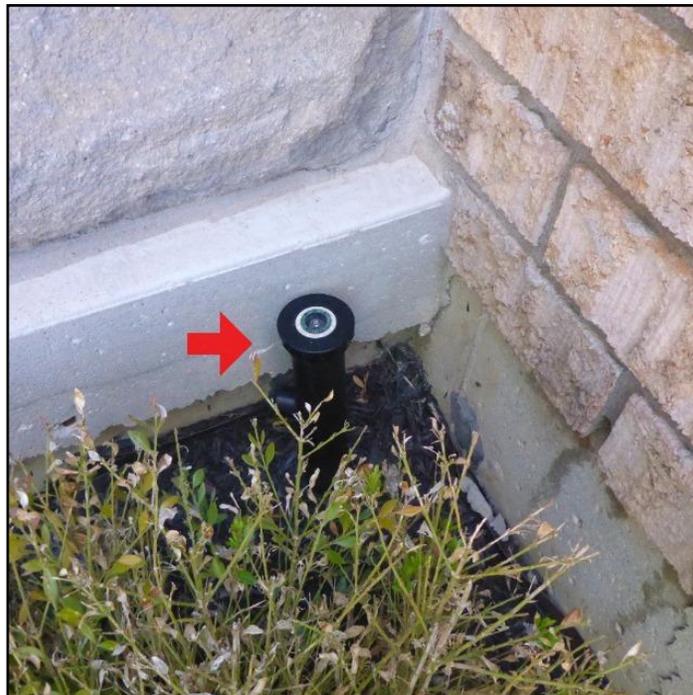
Condition: • Care should be taken with lawn sprinkler systems (irrigation systems). These can wet and damage exterior walls and cause leakage problems into basements and crawlspaces. Water should not be directed against or adjacent to the building.

Reconsider irrigation against foundation

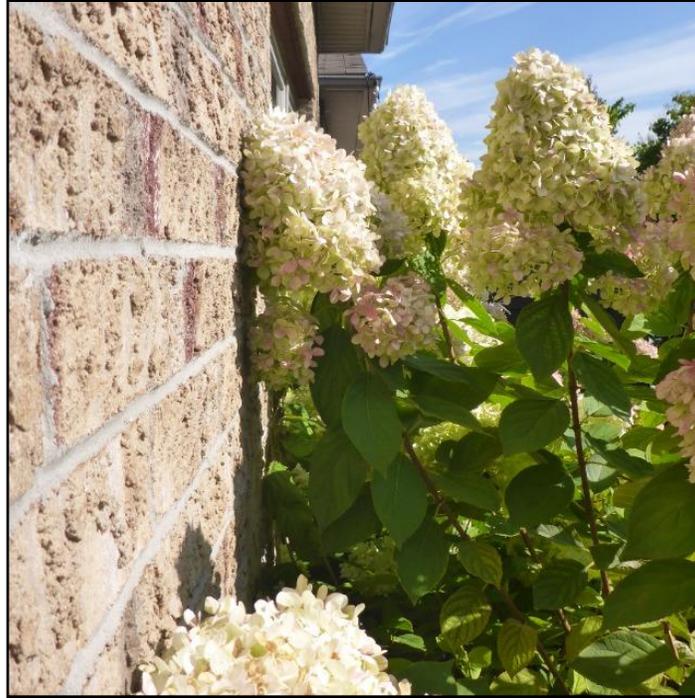
Condition: • [Shrubs/trees too close to building](#)

Keep shrubs trimmed back

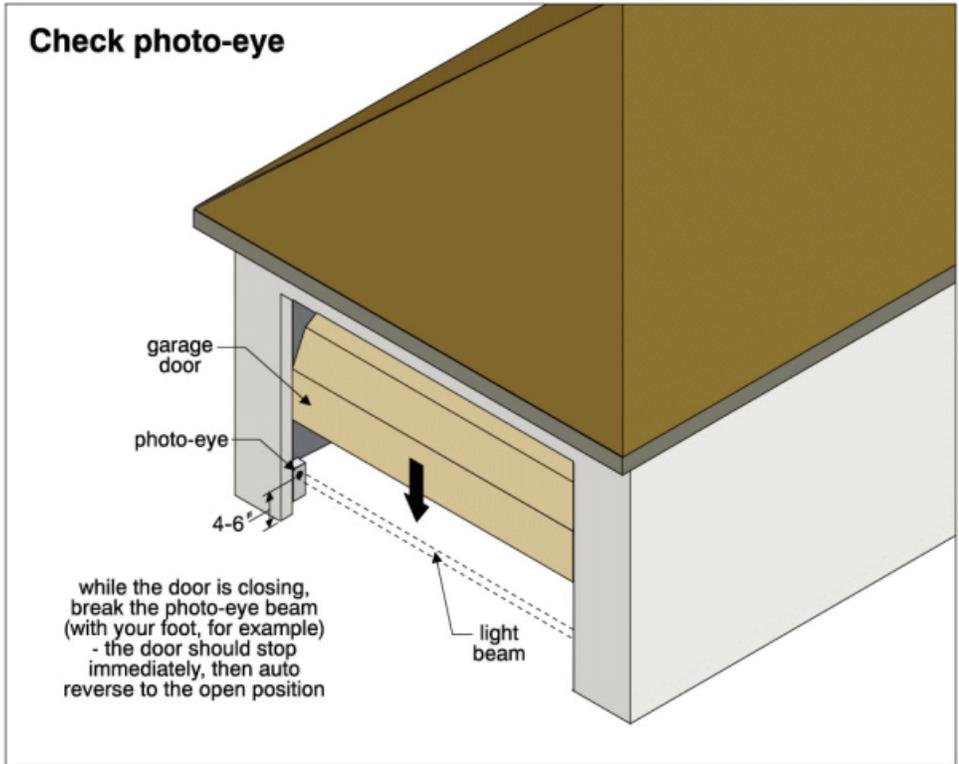
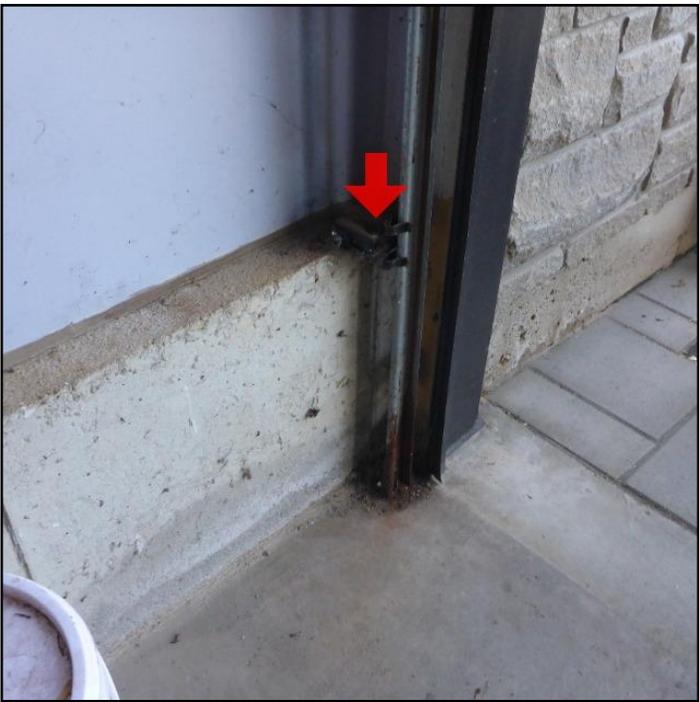
Photo eye

Condition: • The photo eye for the garage door opener is high. There appears to be no option to install it lower. Be careful if toddlers are present.

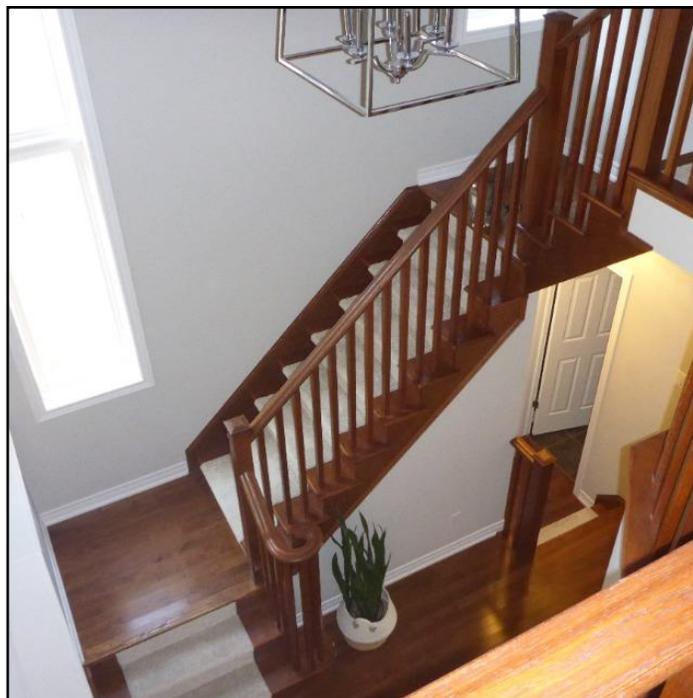
Condition: • Dramatic house designs bring with them a heating and cooling challenge. As hot air rises within the wide open spaces, this can create comfort issues in both the summer and winter months. The location of supply registers is important and the provision for enough return air flow is critical. Ultimately, this is a lifestyle decision and the true evaluation will be over the course of an entire year. Consultation with a heating contractor is recommended if required.

Open concept

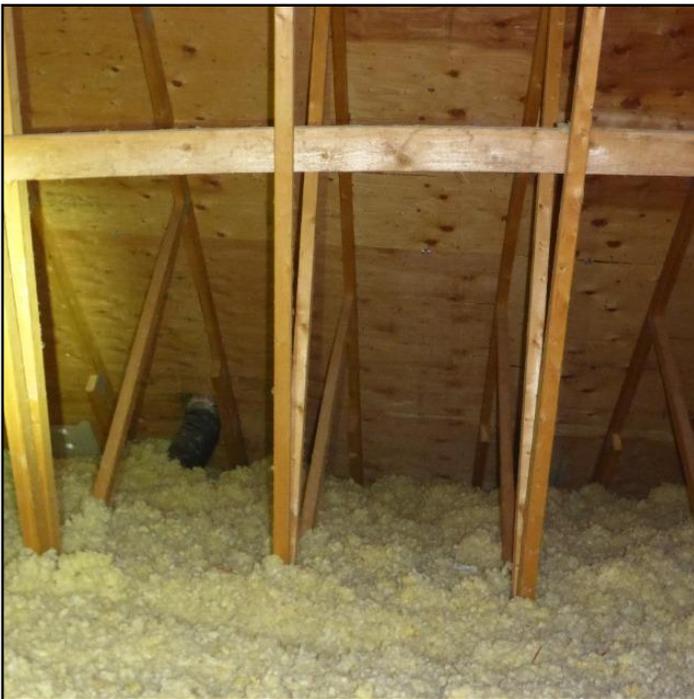
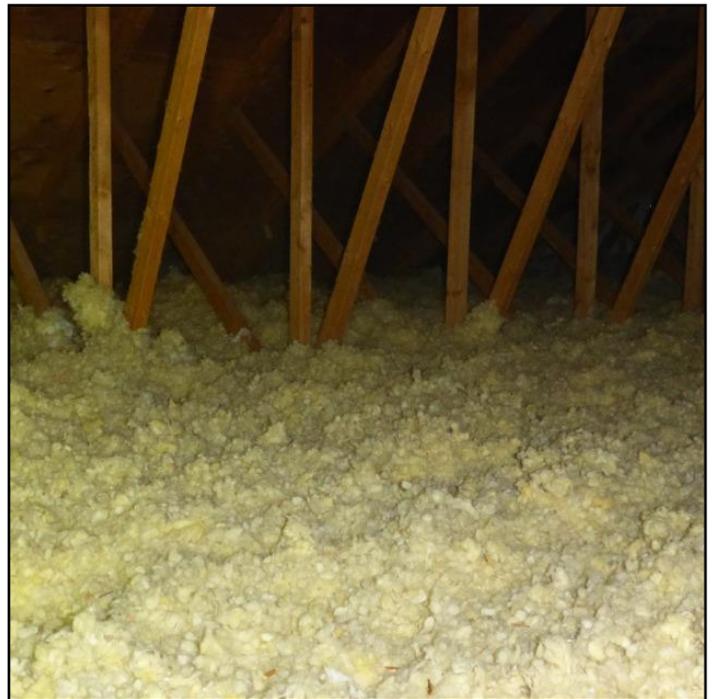
Condition: • View of attic:

Condition: • The insulation levels are less than current standards. Adding insulation would be considered an improvement and would fall under the 'discretionary' category in terms of timing.

Condition: • Some evidence of mice activity was noted in the attic. This is common and no action is required. If activity is detected, a pest control company can be contacted for assistance.

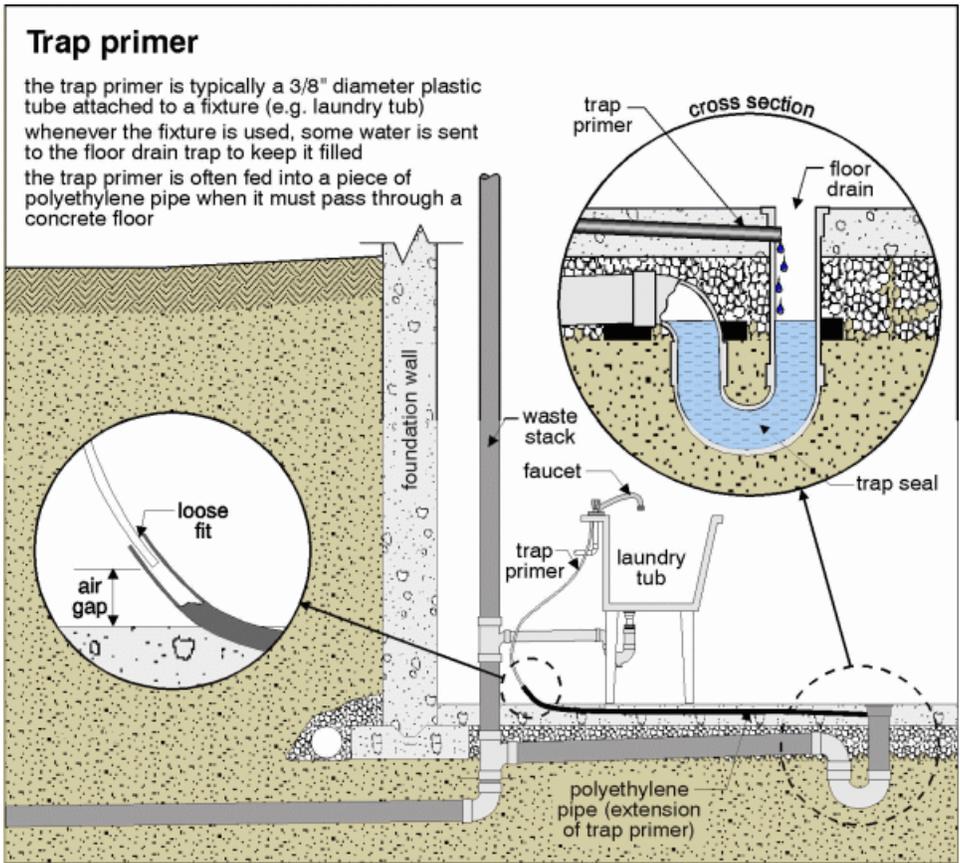
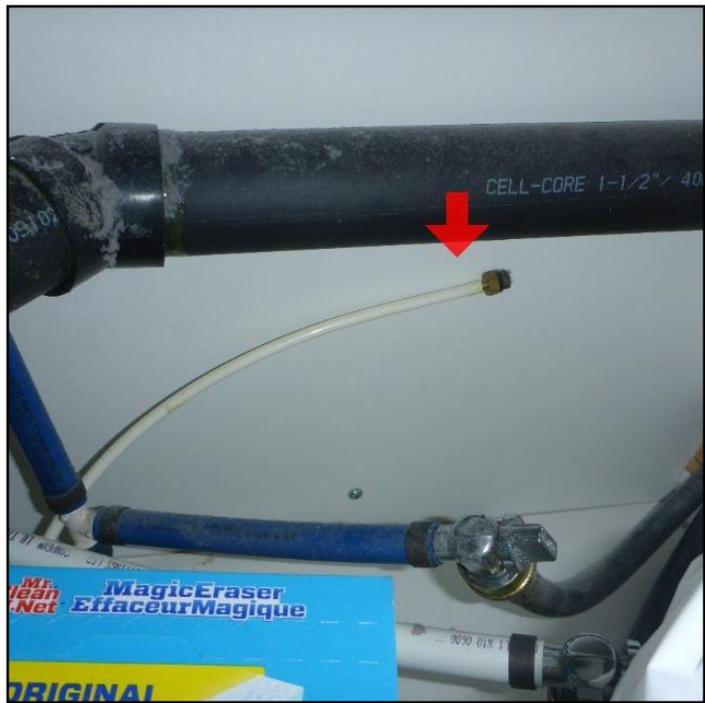
Condition: • Trap primer missing/disconnected

This is not likely to cause problems. There is water running into the floor drain 365 days of the year (assuming air conditioning is used). No action is required.

Disconnected trap primer

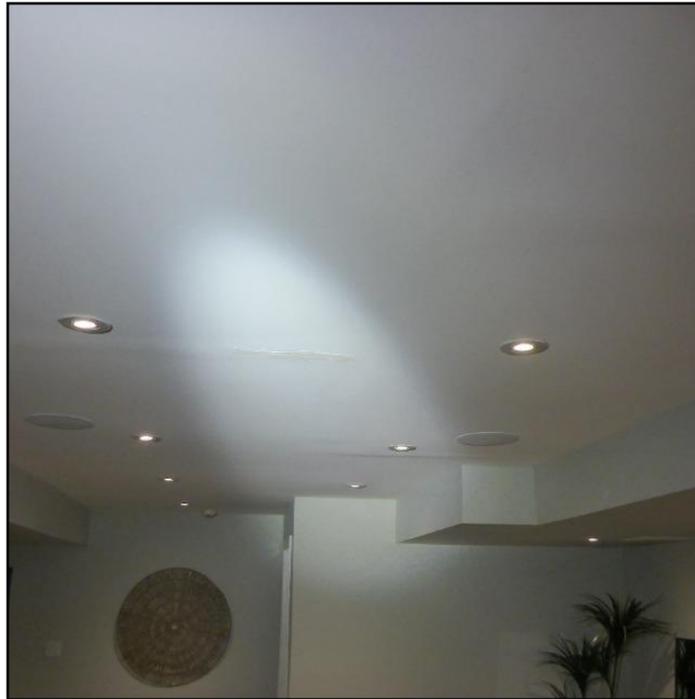
Condition: • Patched - Dry when tested at inspection

Patched in basement
