# YOUR Inspection Report

8 Cumberland Drive  
Mississauga, ON L5G 3M6

Thursday, October 9, 2025

Report No. 9200, v.2

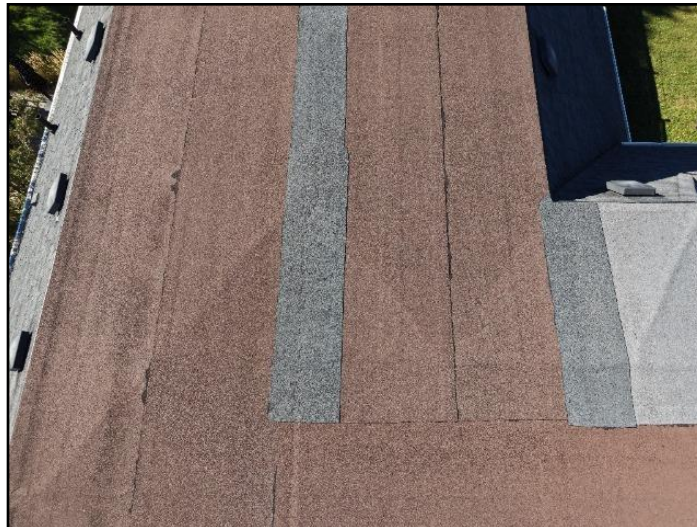
**Condition:** • Patched

It is unclear if this was during original construction - the current homeowner may have insight

*Patched flat roof*

The installed flat roof covering is 13 years old. This type of flat roof has a typical total life expectancy of 20 years. Monitor over time and maintain as necessary.

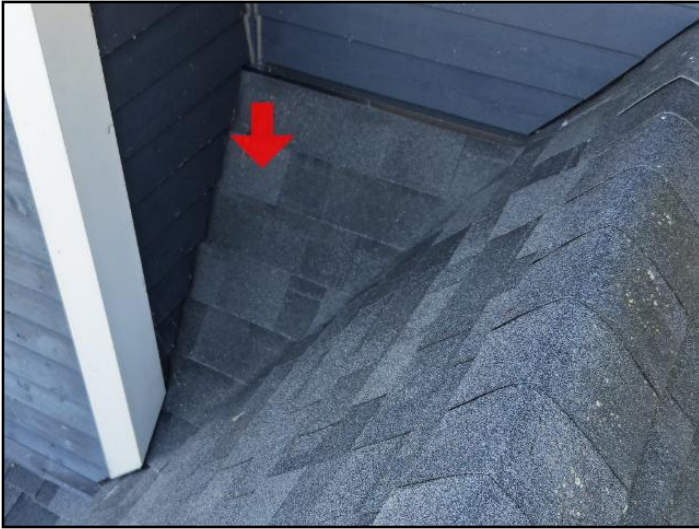
**Condition:** • Flashings are vulnerable areas

**Condition:** • 'Log jam' roof design will be more prone to water issues.

*Vulnerable area*

**Task:** Monitor/maintain as necessary

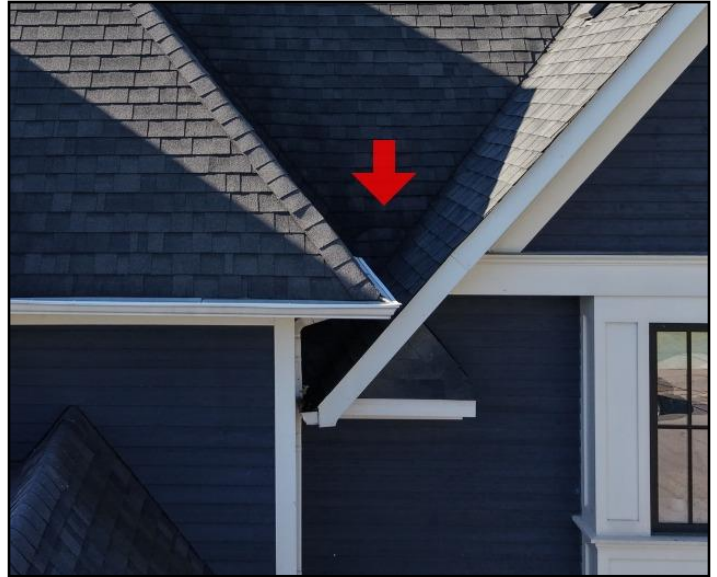
*Vulnerable area*

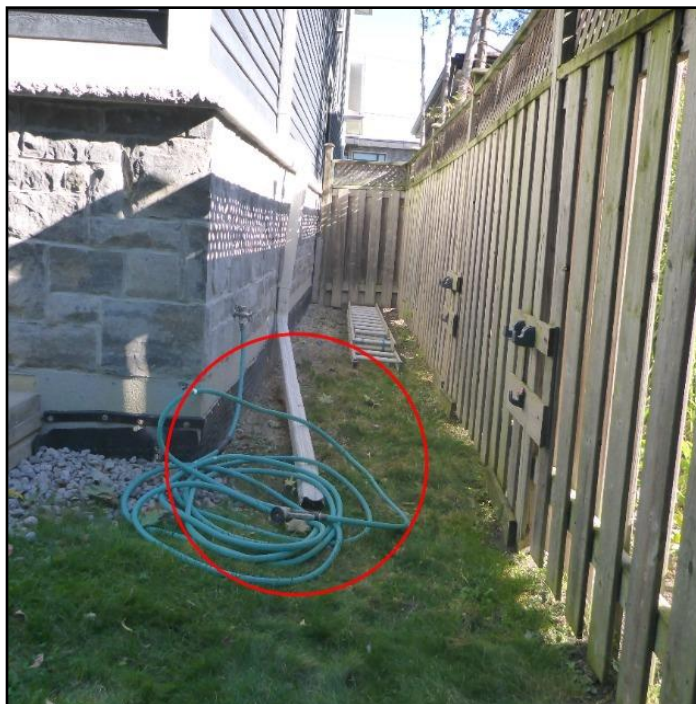
**Condition:** • [Downspout ends too close to home. It should direct water at least 6 feet from building.](#)

*Extend downspouts away from foundation*

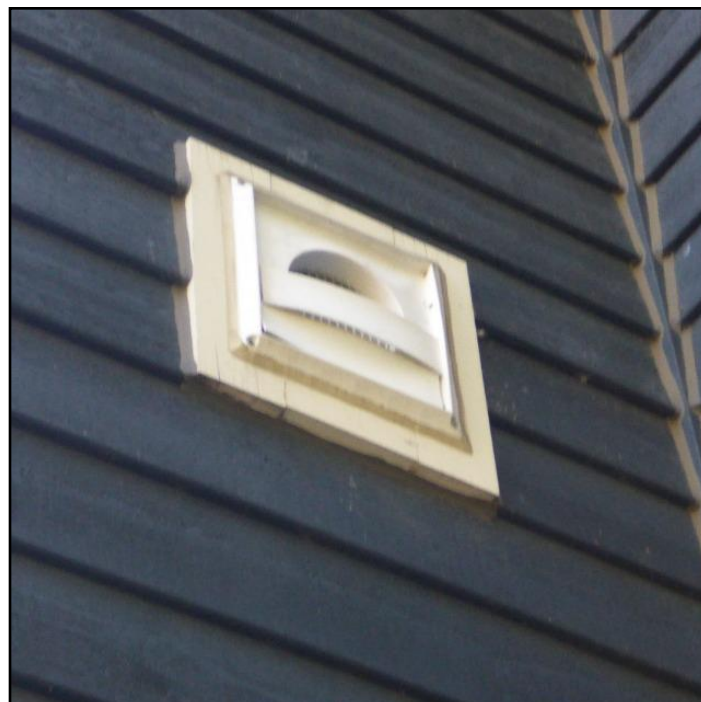
Condition: • [Vent damaged](#)

*Missing louver*

Task: Repair as part of regular maintenance

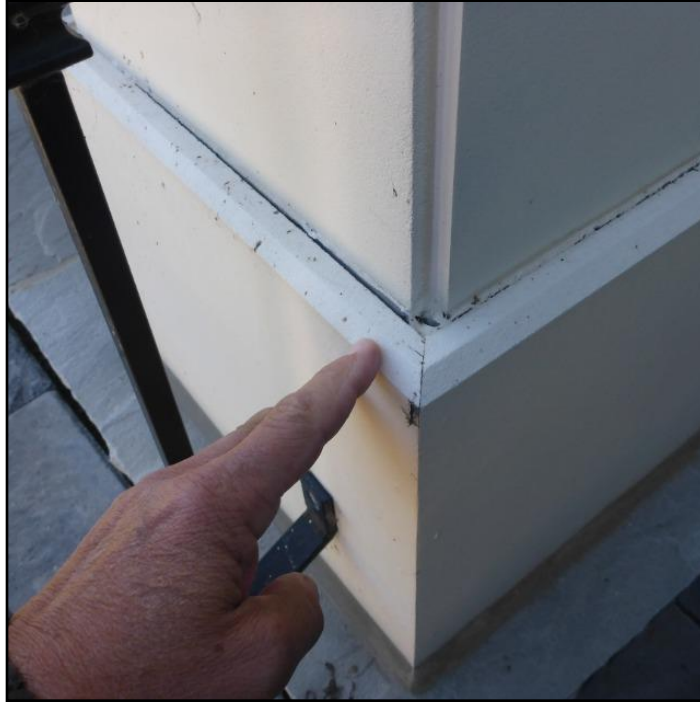
Condition: • Regular maintenance is important

*Wood columns require careful maintenance*

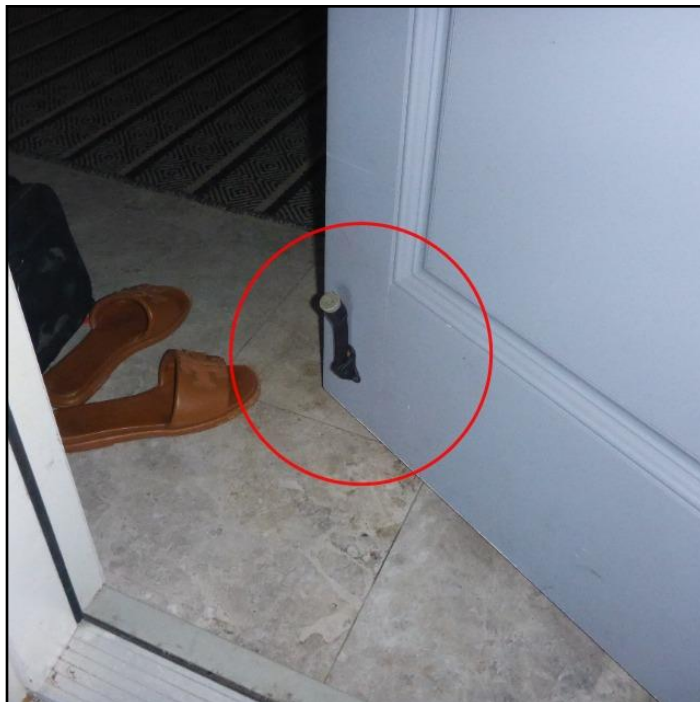
Condition: • [Man-door closer ineffective \(8.3\)](#)

*Remove door stopper*

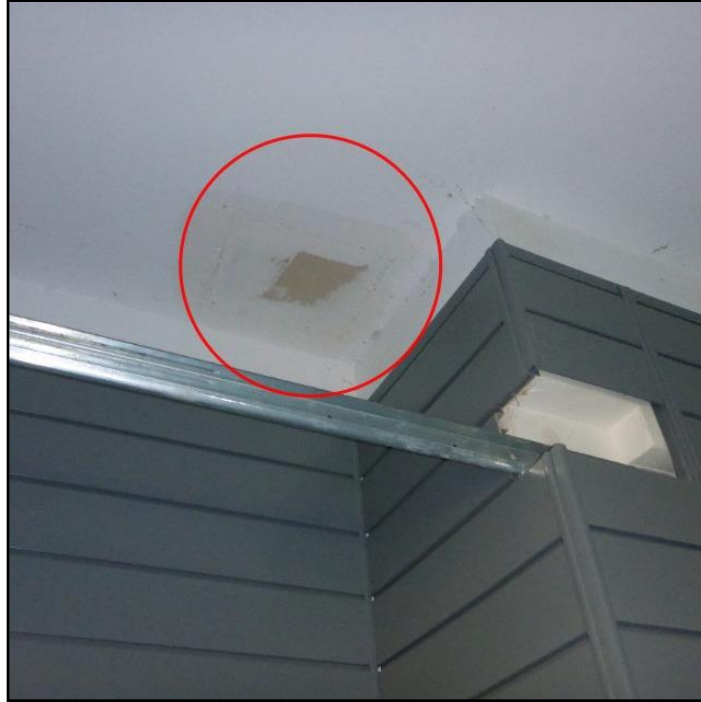
**Condition:** • Patched garage ceiling noted

*Patched in garage*

**Task:** Ask homeowner for insight

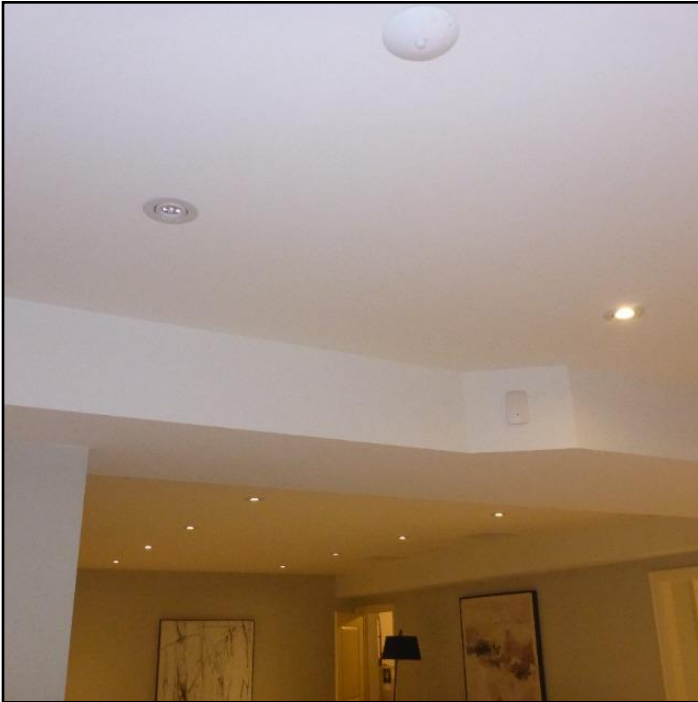
Basement

Condition: • [Inoperative](#)

Various lightbulbs were not working. It is assumed that these are burned out bulbs but this was not confirmed.

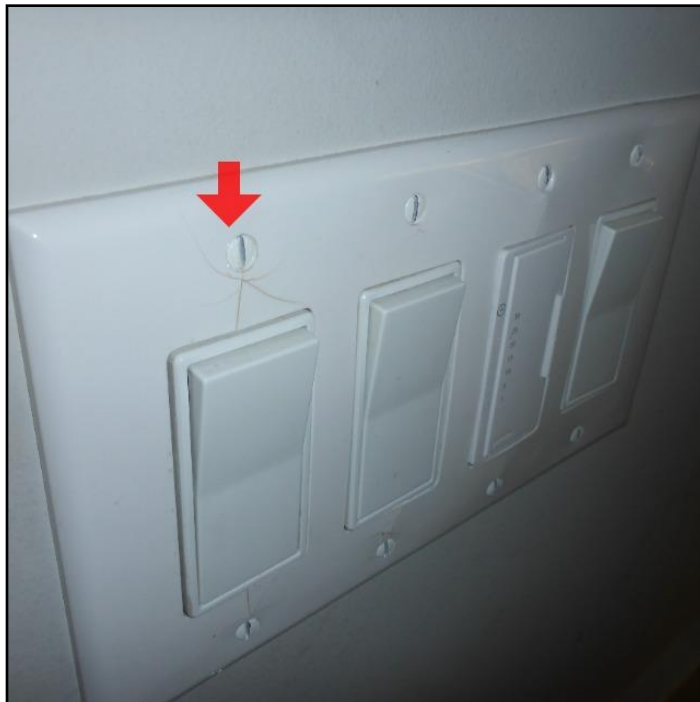
Condition: • [Damage](#)

*Cracked at primary ensuite*

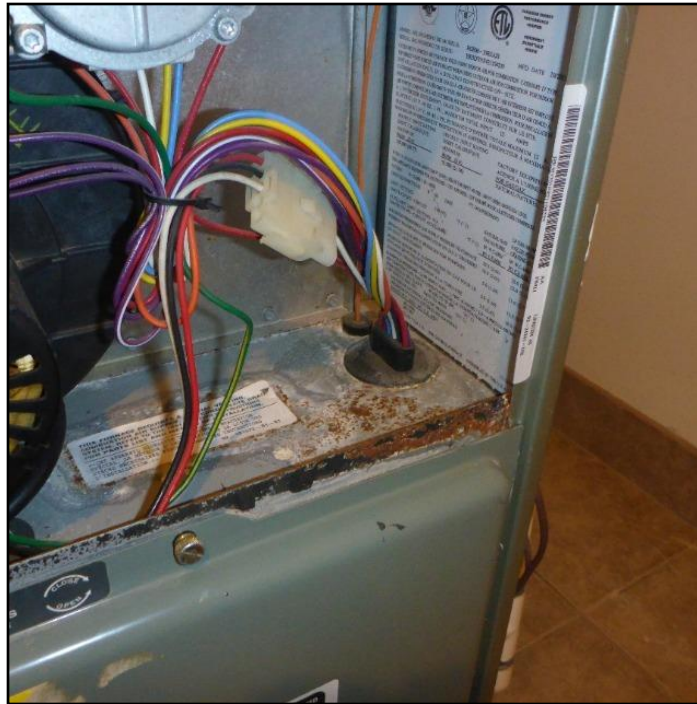
**Condition:** • Prior condensate leaks noted inside furnace cabinet.  
This is a heating issue. Monitor during the heating season.

*Stains inside furnace cabinet*

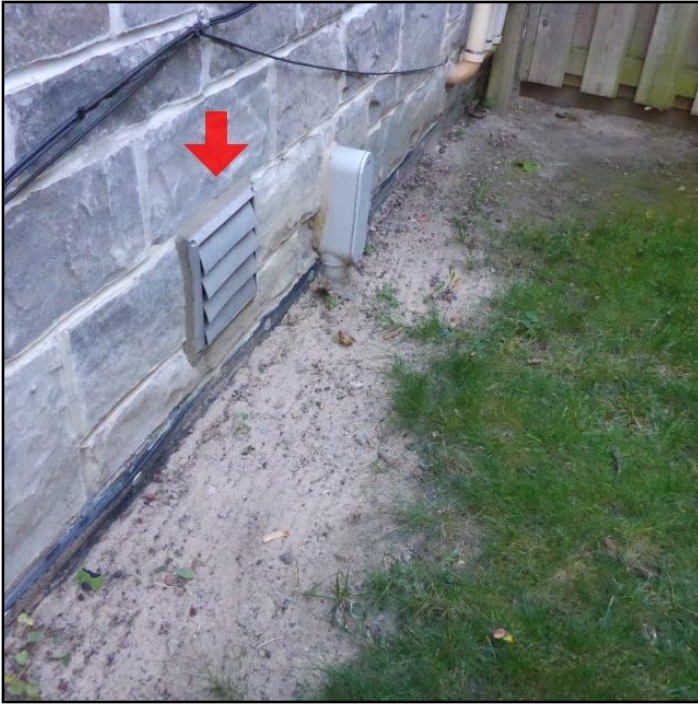
**Condition:** • The intake and exhaust vent locations are less than ideal. Consultation with a heating contractor is recommended to determine if improvements are warranted.

*Too low*

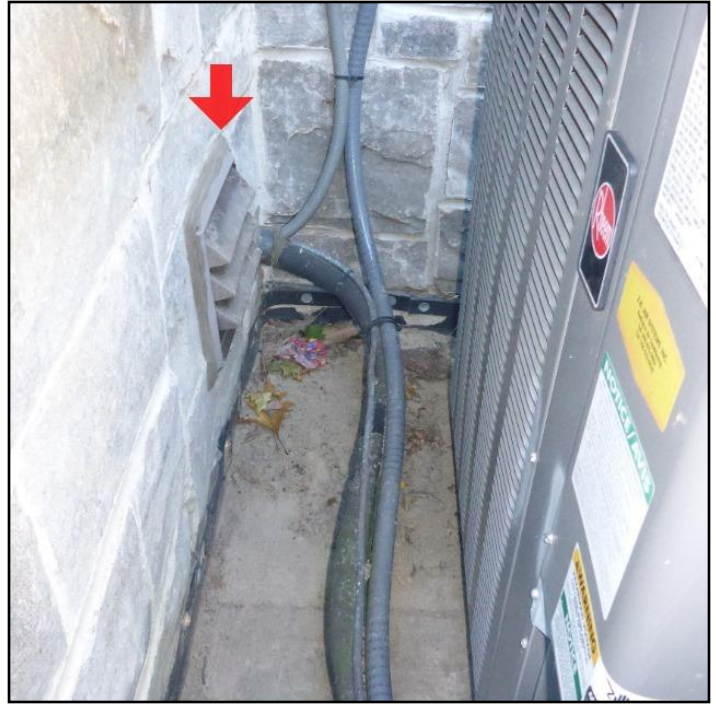
*Should not be in corner*

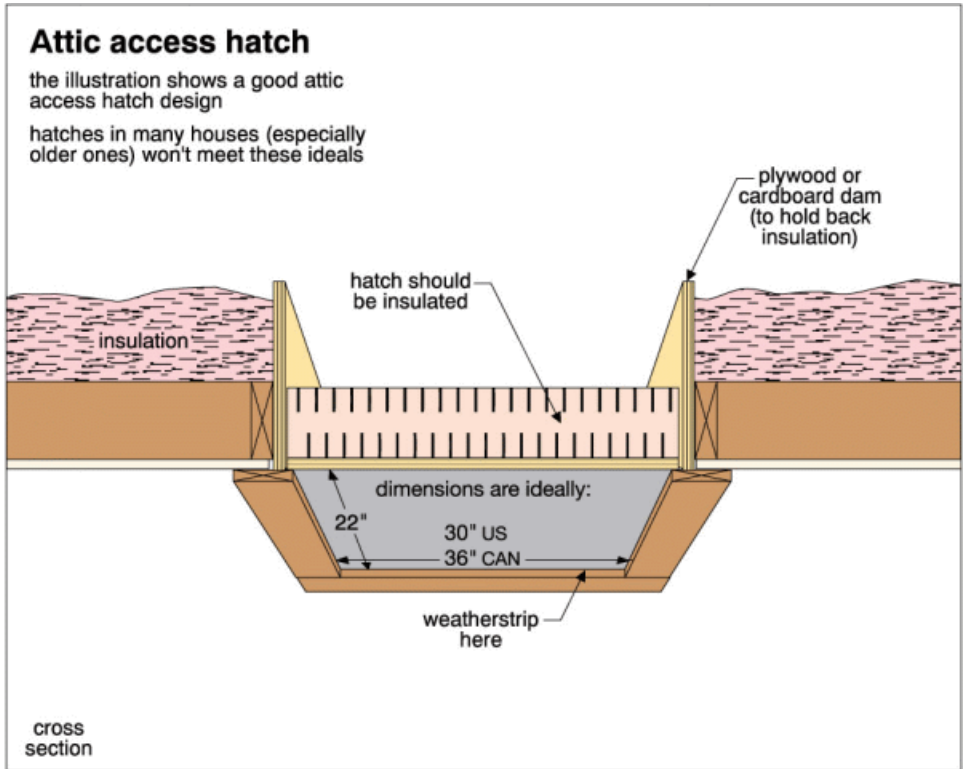
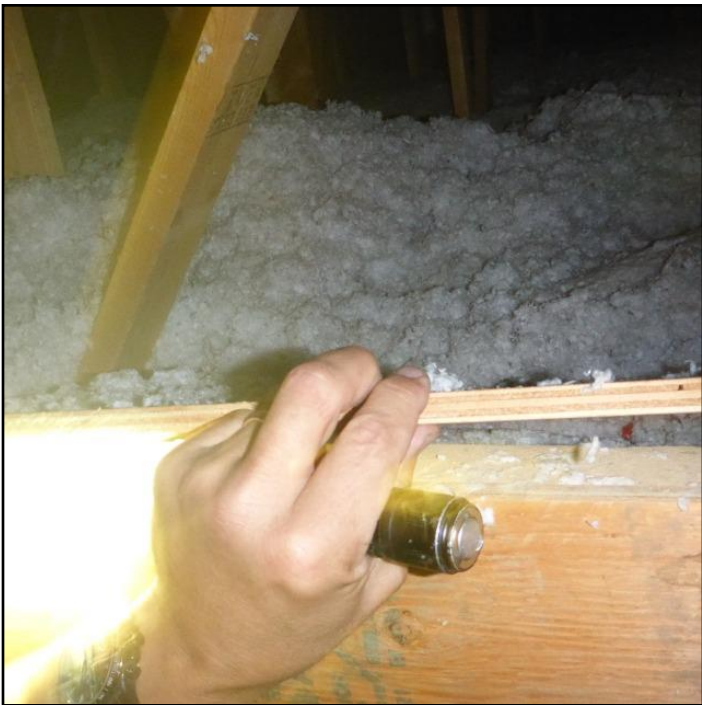
**Condition:** • Access hatch insulation/weatherstripping/fit less than ideal

*Missing insulation*

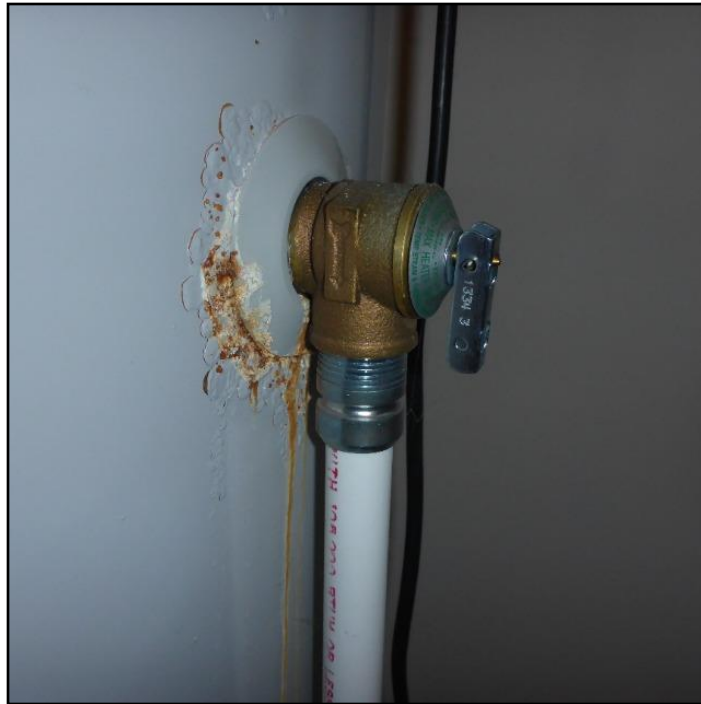
**Condition:** • [Near end of normal life expectancy](#)

*Corroded water heater*

**Task:** Replace

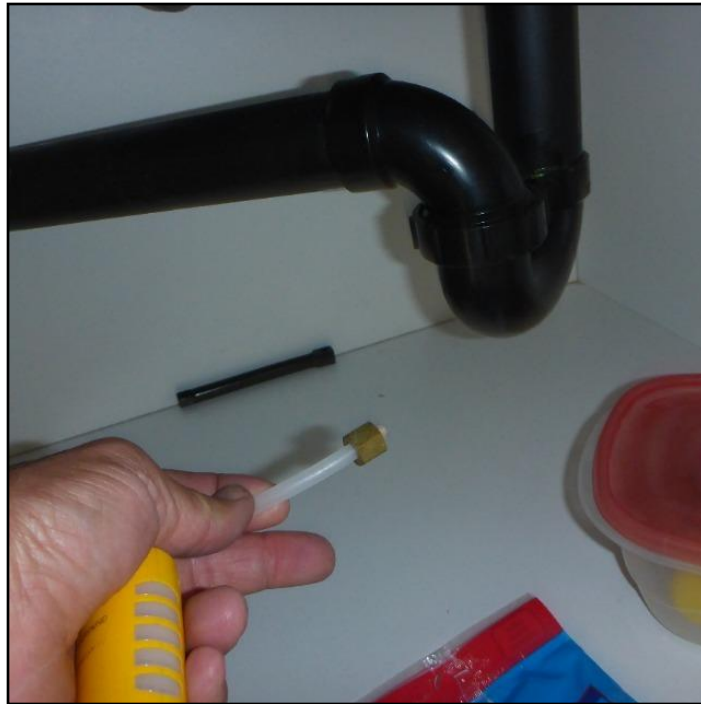
**Condition:** • Trap primer missing/disconnected

*Disconnected at laundry room*

This is not likely to cause problems. If concerned, hook the trap primer back up or pour mineral oil down the floor drains (won't evaporate and environmentally friendly).

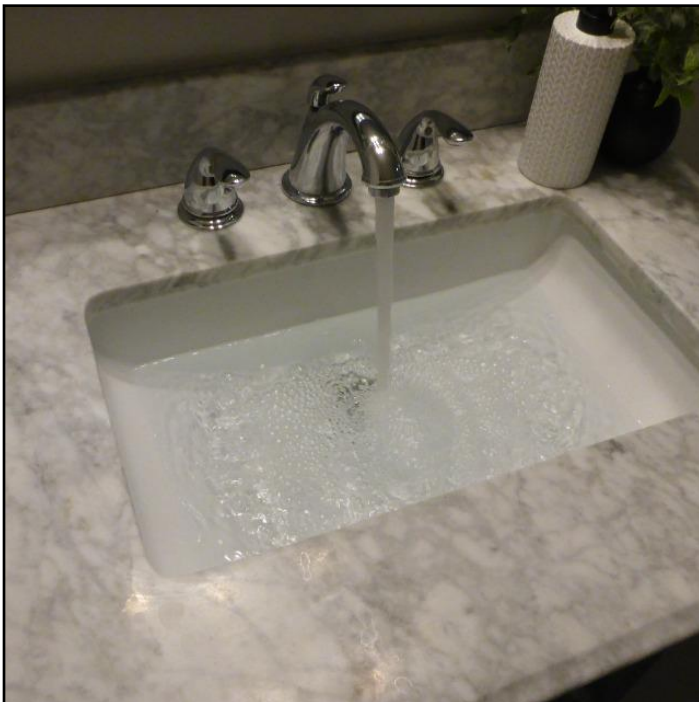
Condition: • [Drain slow](#)

*Slow drain in basement*

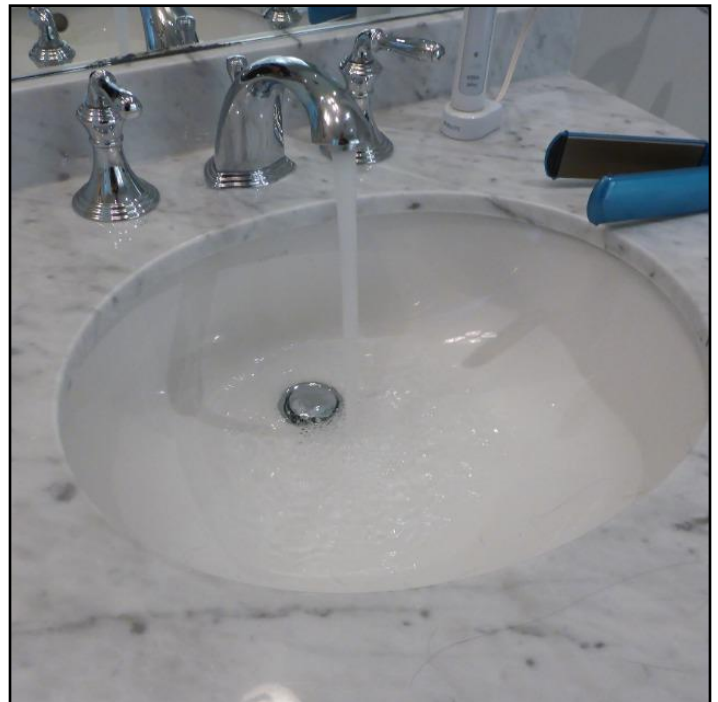
*Slow drain at primary ensuite*

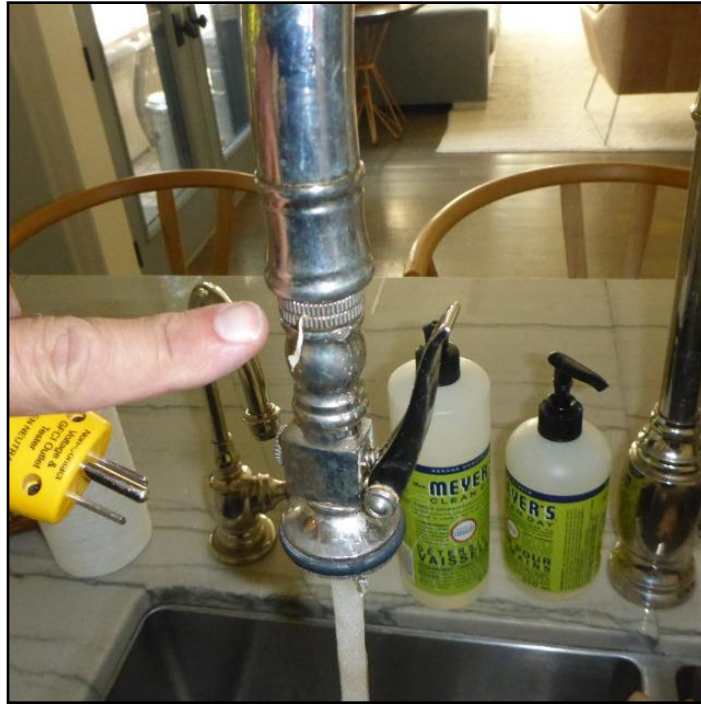
Condition: • [Leak](#)

*Leak at kitchen*

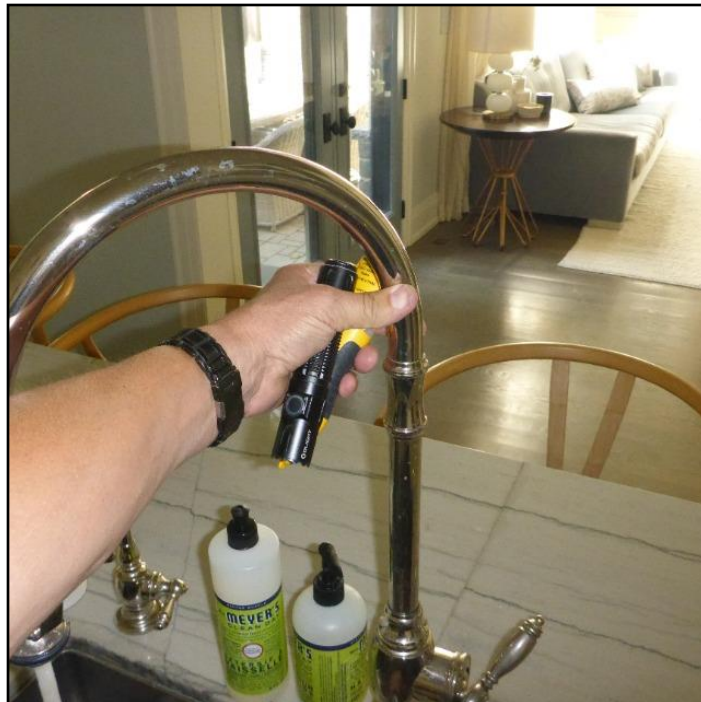
Condition: • [Loose](#)

*Loose at kitchen*

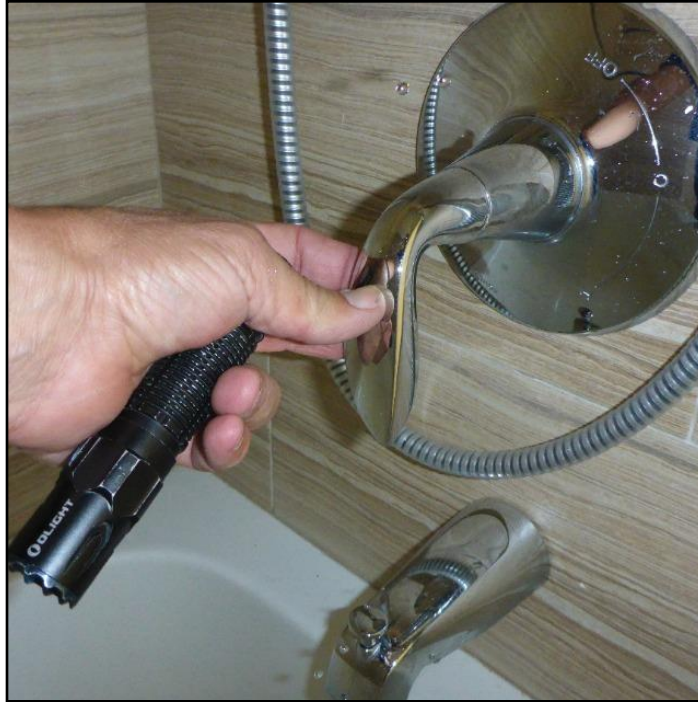
**Condition:** • Loose handle noted

*Loose handle at tub*

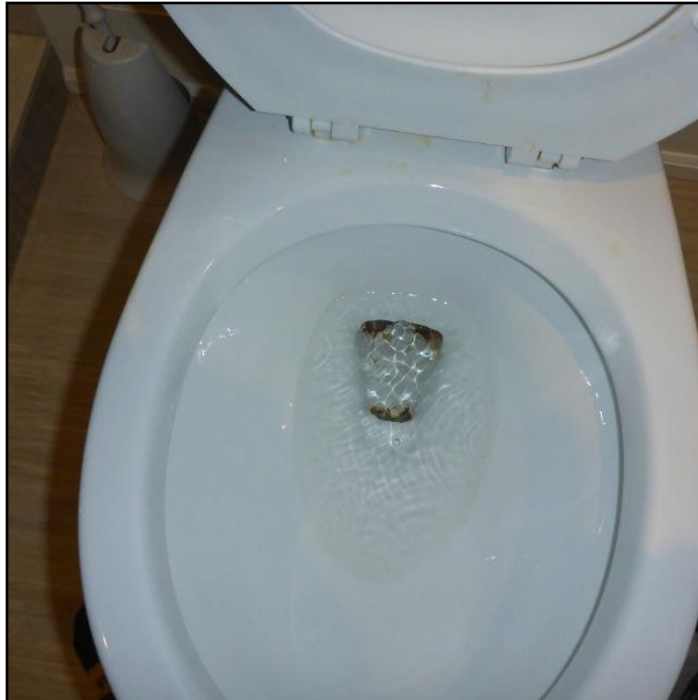
**Condition:** • Stains noted at toilet bowl. These are often permanent.

*Stained toilets*

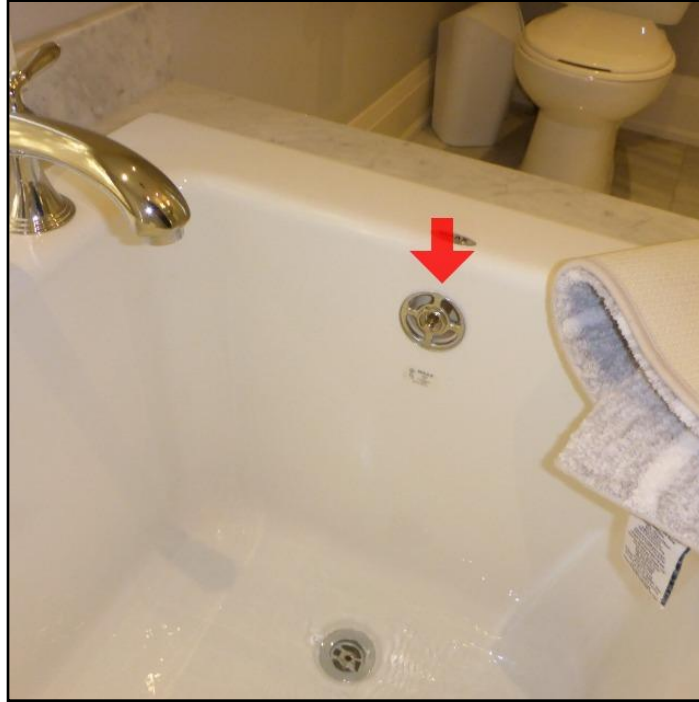
**Condition:** • Overflow cover is missing

*Missing cover in primary ensuite*

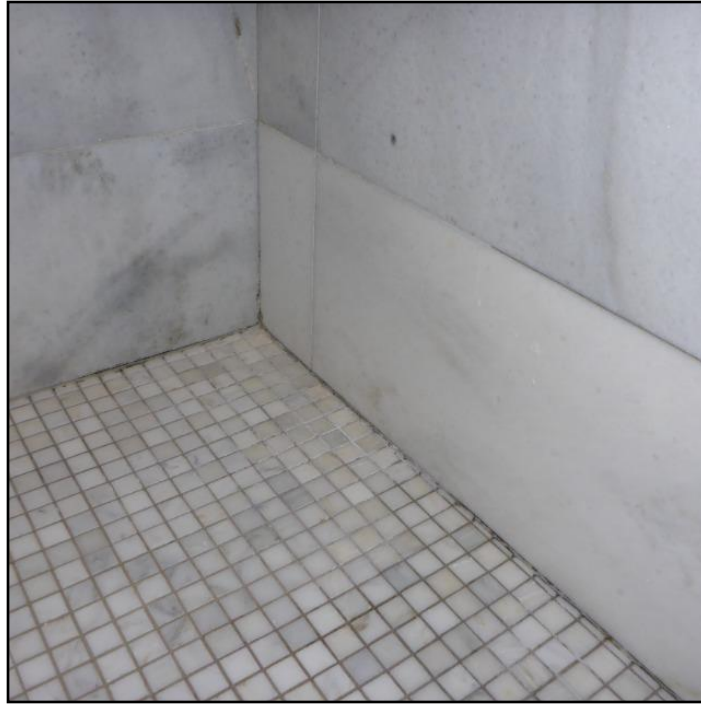
**Condition:** • Caulking and grout should be checked every six months and improved as necessary to prevent leakage and damage behind wall surfaces.

*Shower stall maintenance required*

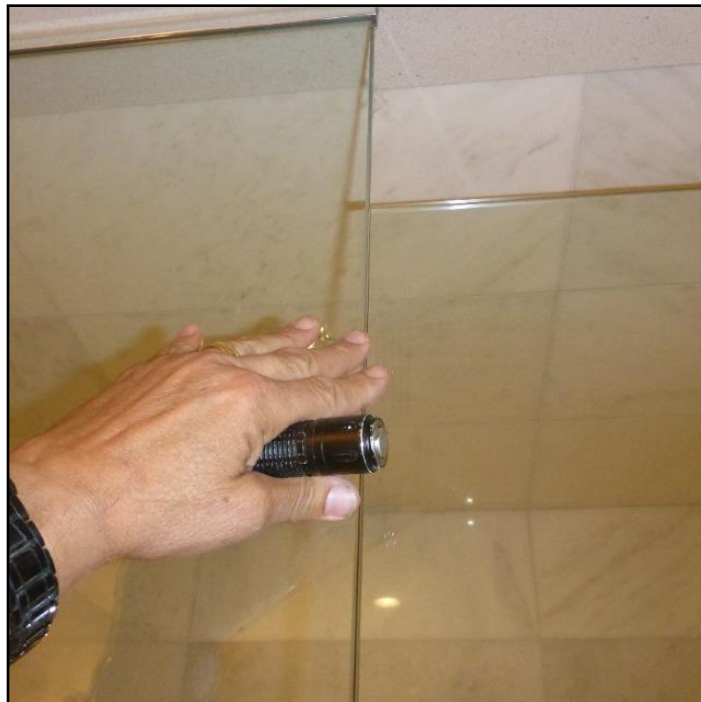
**Condition:** • [Door - adjustment needed](#)

**Location:** Basement bathroom

*Door hits at top*

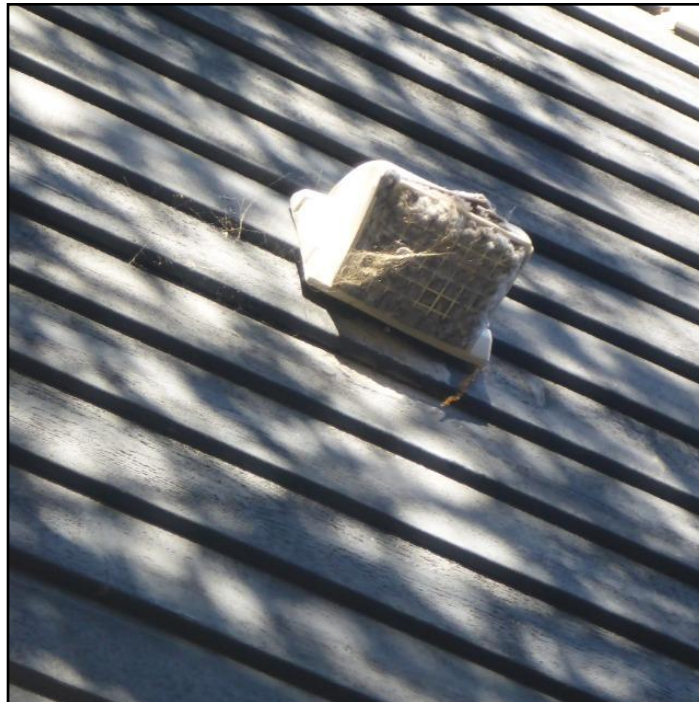
**Condition:** • Plugged dryer vent

*Plugged dryer vent*

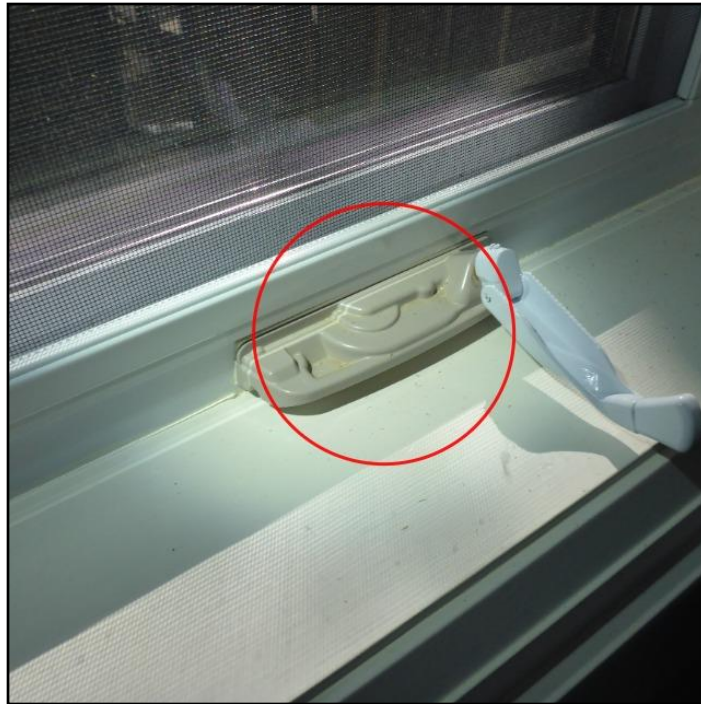
**Condition:** • [Hardware missing or defective](#)

*Missing cover in dining room*

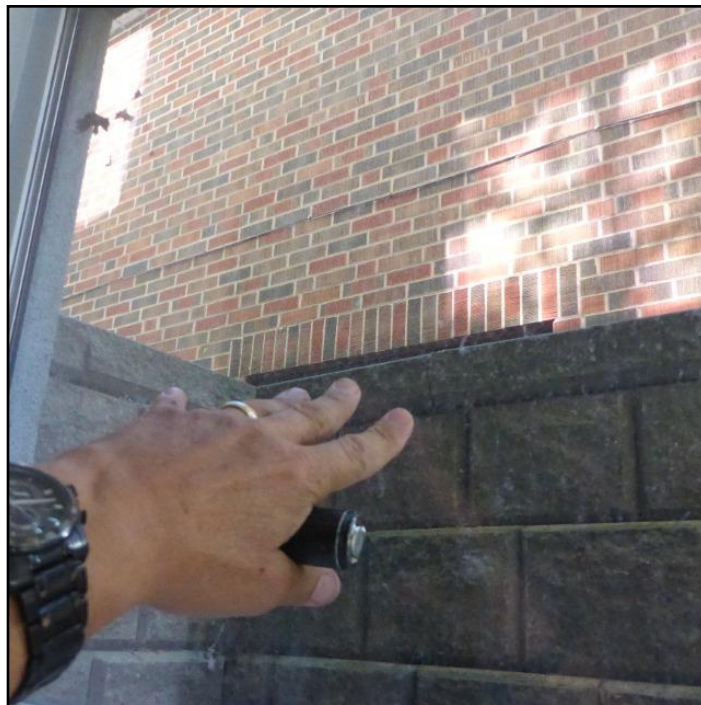
Condition: • [Screen missing](#)

*Missing screens in basement*

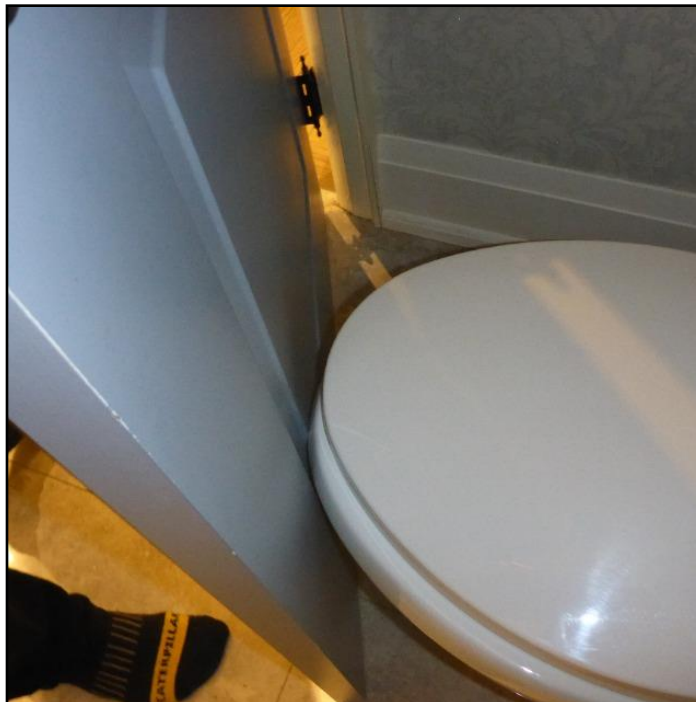
**Condition:** • Missing door stops noted.

*Missing door stop in powder room*
