YOUR Inspection Report

8 Cumberland Drive
Mississauga, ON L5G 3M6

Thursday, October 9, 2025

Report No. 9200

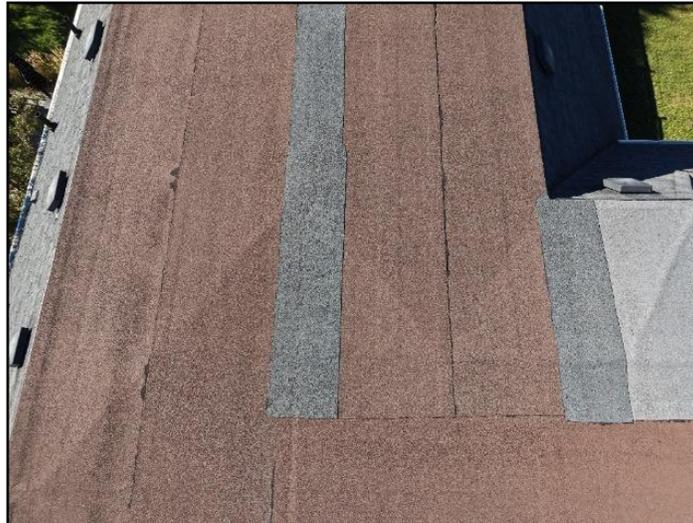
Condition: • Patched

It is unclear if this was during original construction - the current homeowner may have insight

Patched flat roof

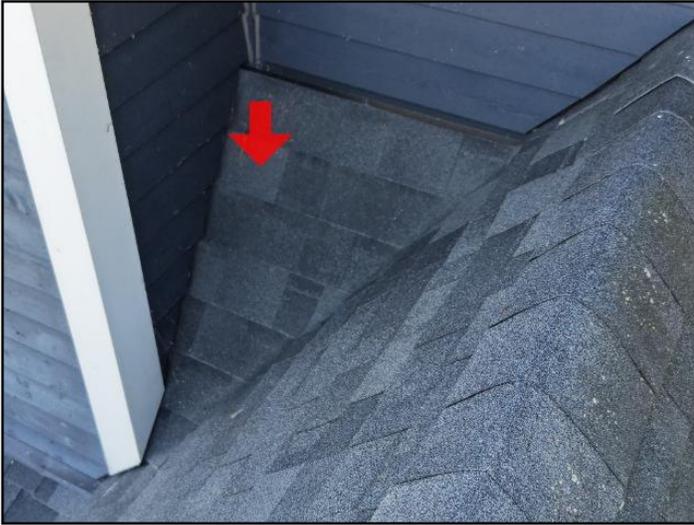
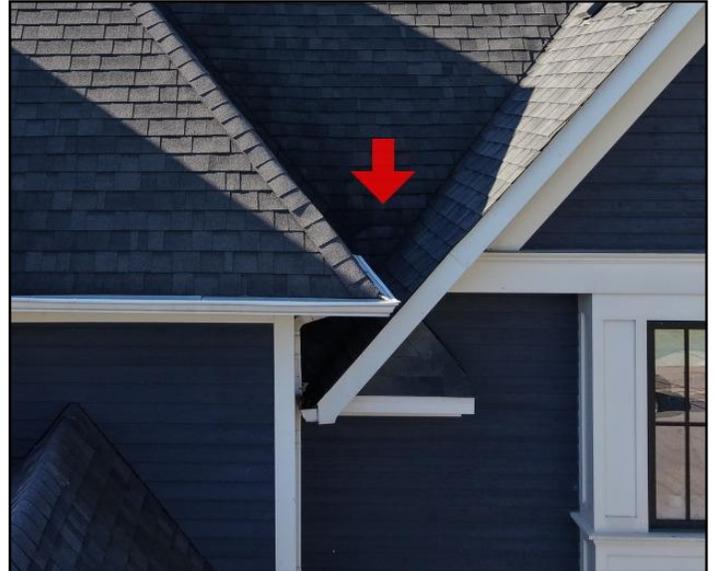
Condition: • Flashings are vulnerable areas

Condition: • 'Log jam' roof design will be more prone to water issues.

Vulnerable area

Task: Monitor/maintain as necessary

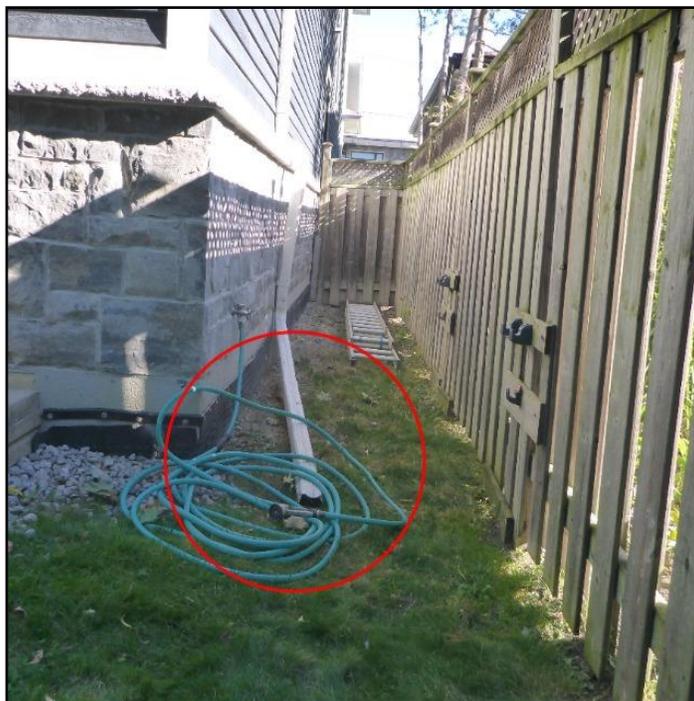
Condition: • [Downspout ends too close to home. It should direct water at least 6 feet from building.](#)

Extend downspouts away from foundation

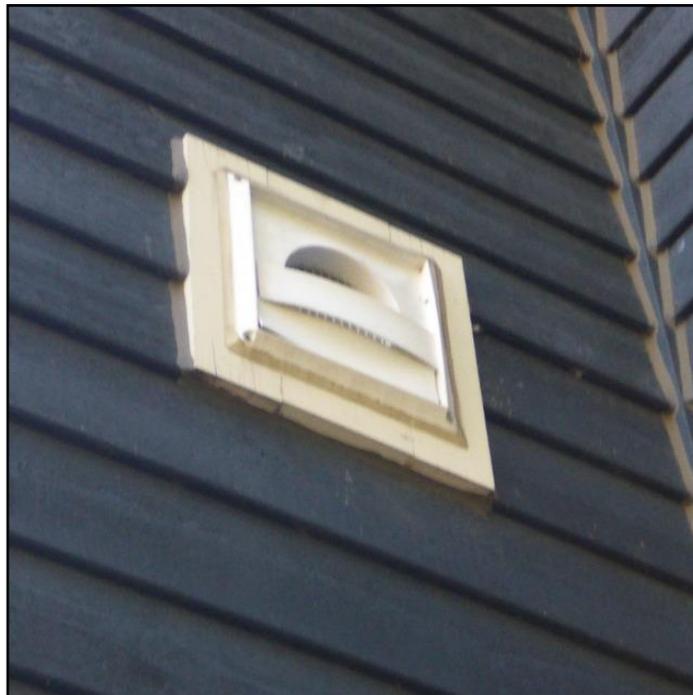
Condition: • [Vent damaged](#)

Missing louver

Task: Repair as part of regular maintenance

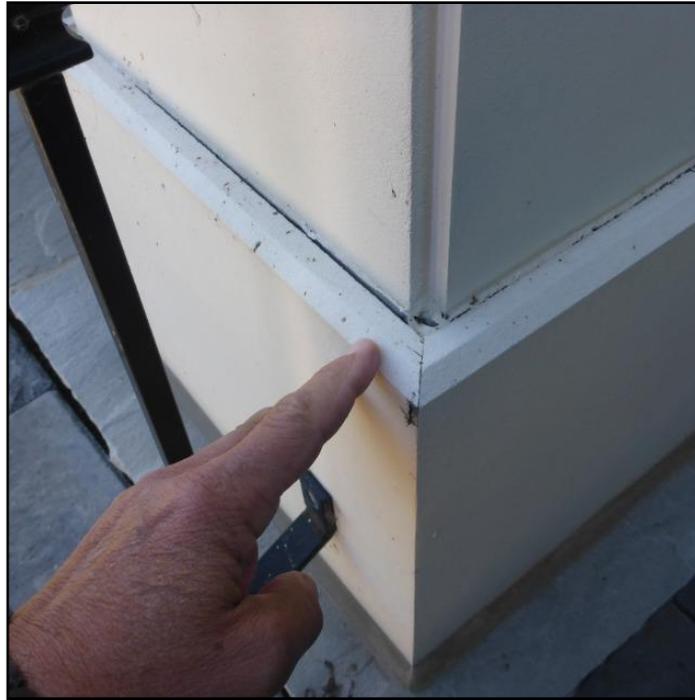
Condition: • Regular maintenance is important

Wood columns require careful maintenance

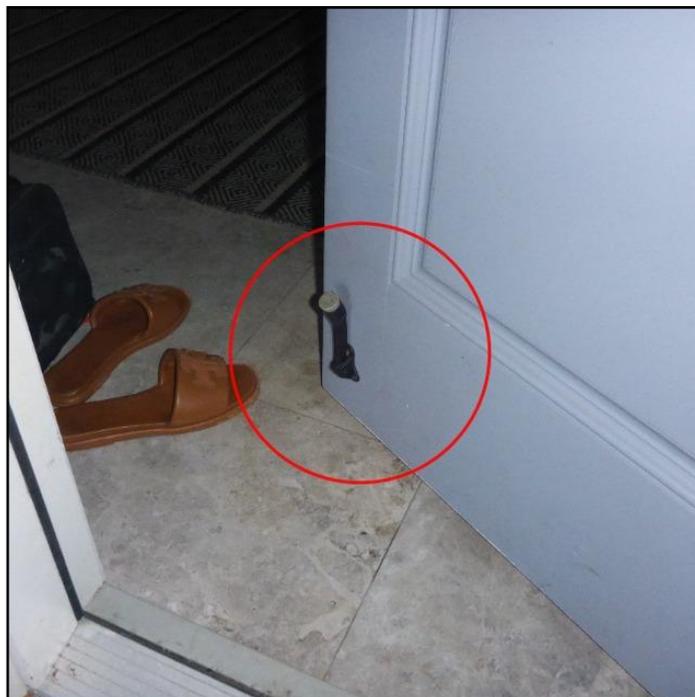
Condition: • [Man-door closer ineffective \(8.3\)](#)

Remove door stopper

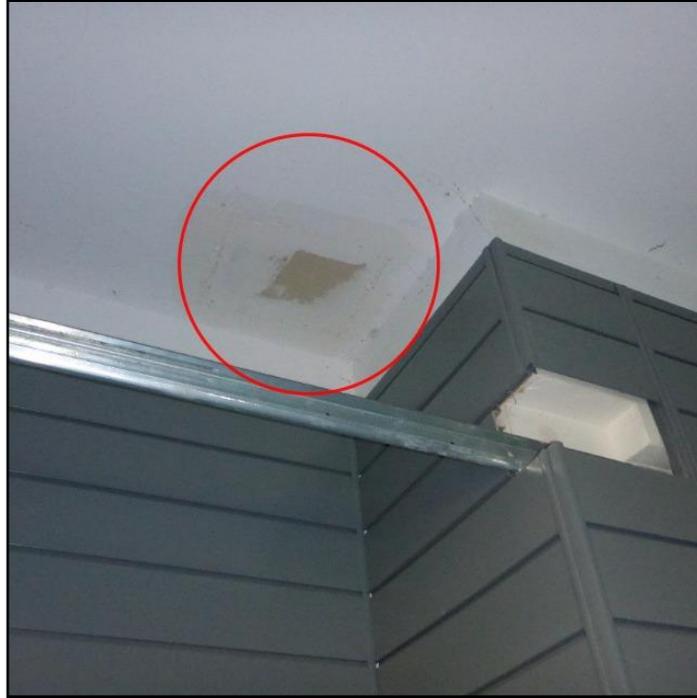
Condition: • Patched garage ceiling noted

Patched in garage

Task: Ask homeowner for insight

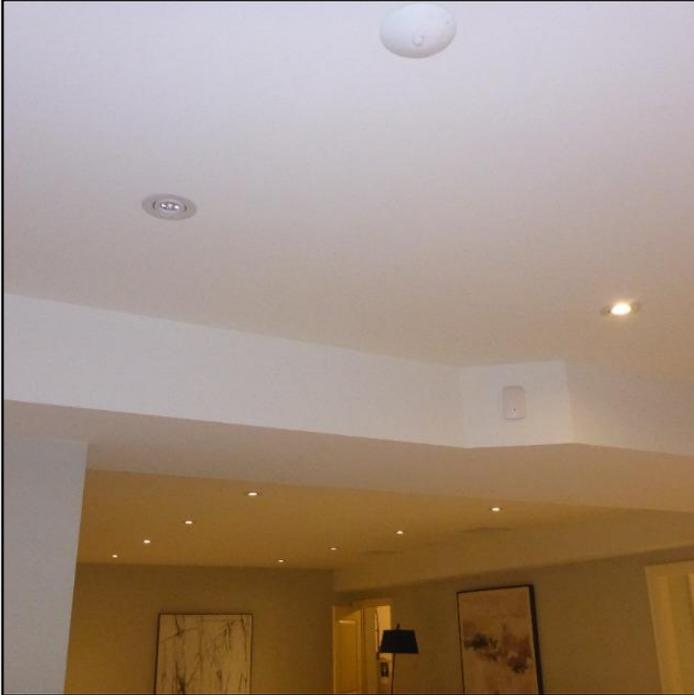
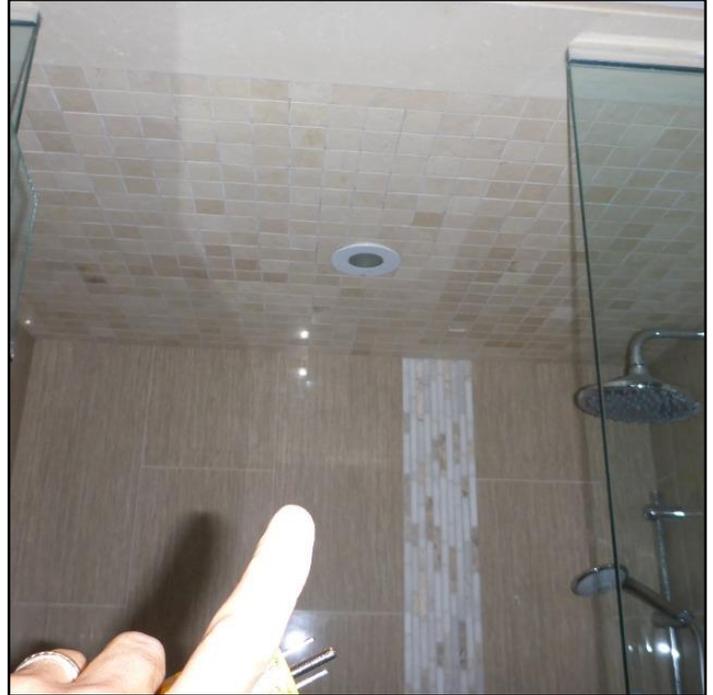
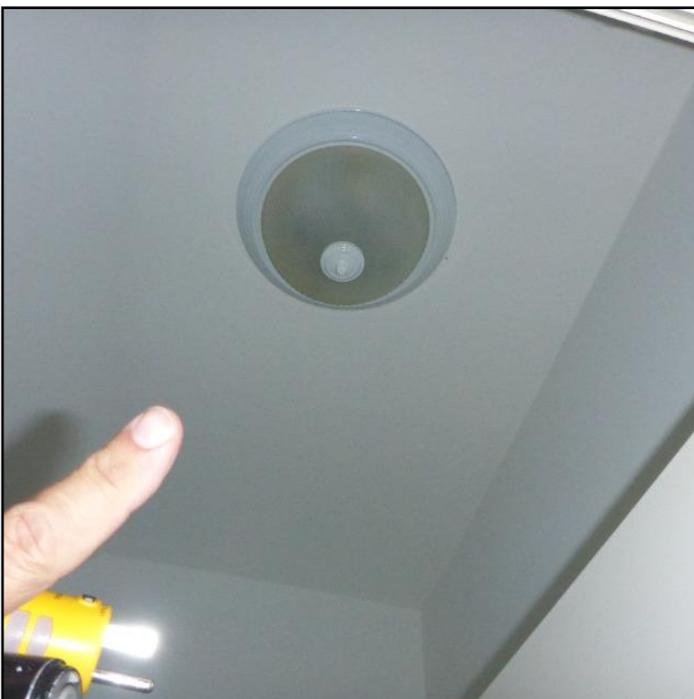
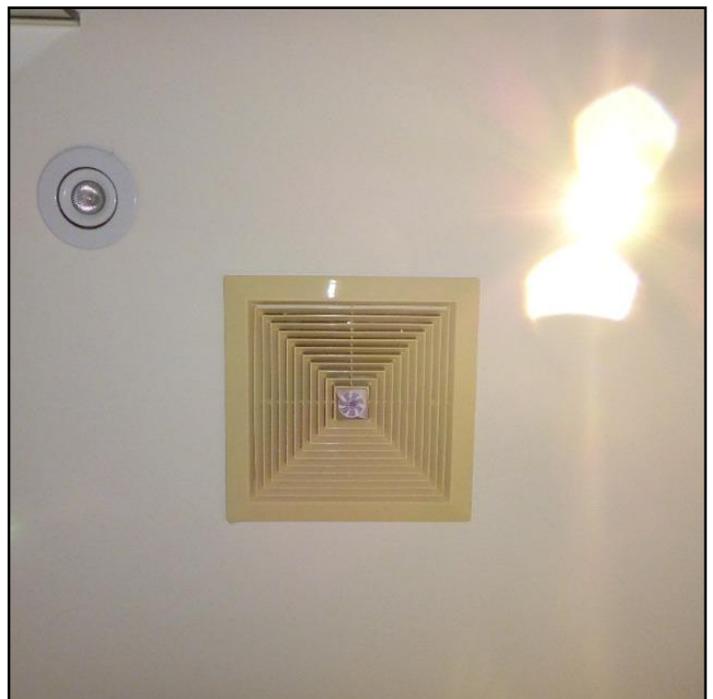
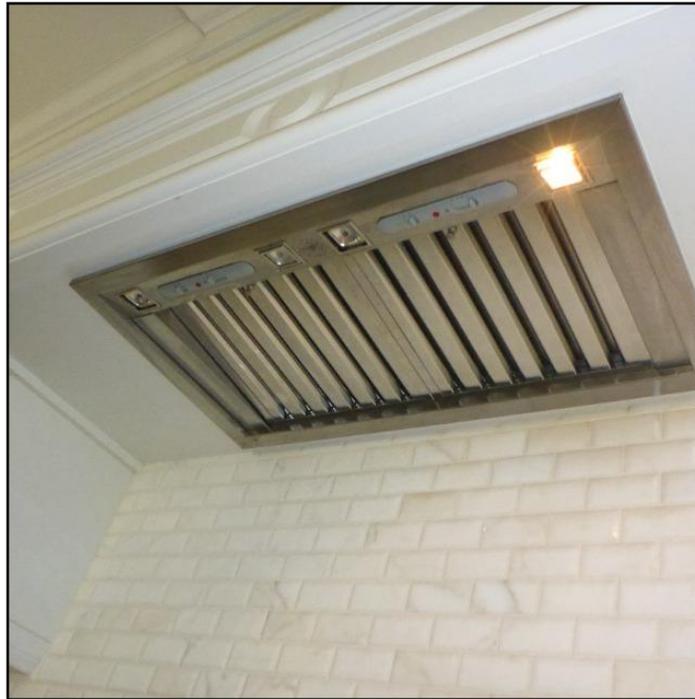
Condition: • [Inoperative](#)

Various lightbulbs were not working. It is assumed that these are burned out bulbs but this was not confirmed.

Basement

Shower stall

Front bedroom closet

Bathroom

Kitchen exhaust

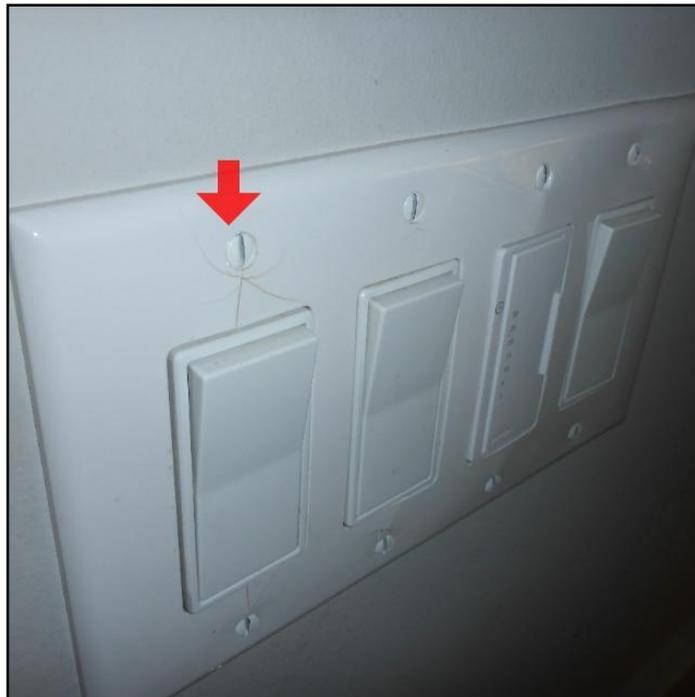
Condition: • [Damage](#)

Cracked at primary ensuite

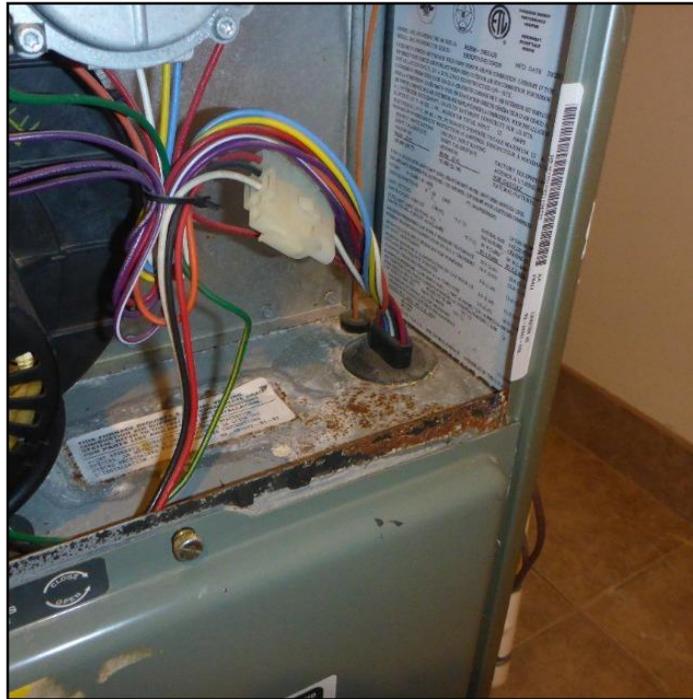
Condition: • Prior condensate leaks noted inside furnace cabinet.
This is a heating issue. Monitor during the heating season.

Stains inside furnace cabinet

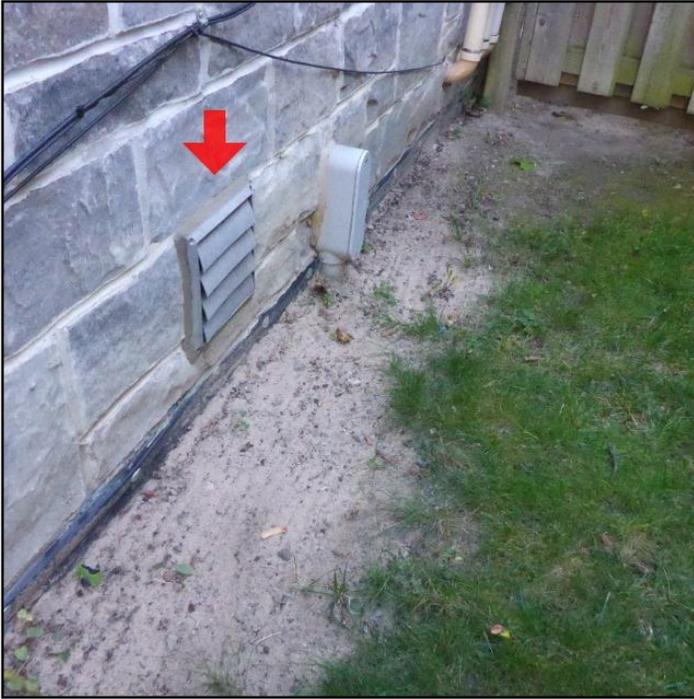
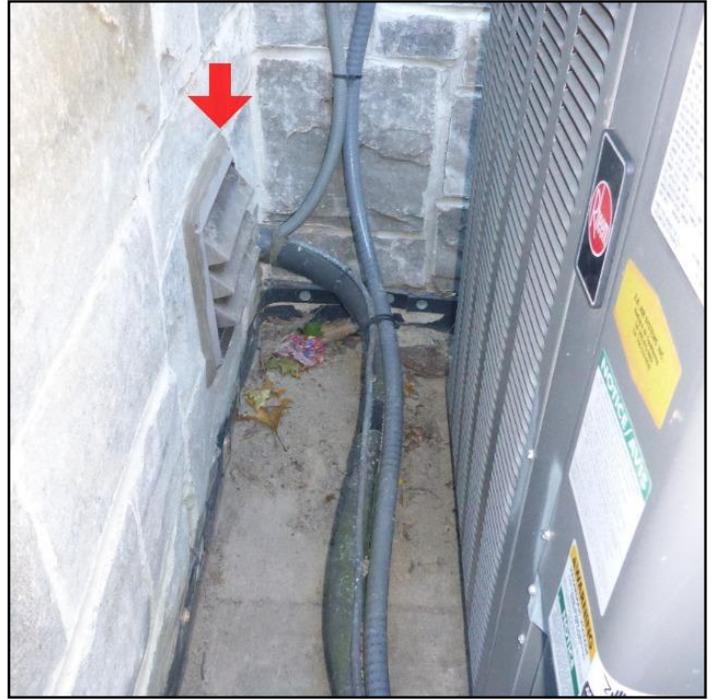
Condition: • The intake and exhaust vent locations is less than ideal. A heating contractor should inspect/comment on need for improvement (if any).

Too low

Should not be in corner

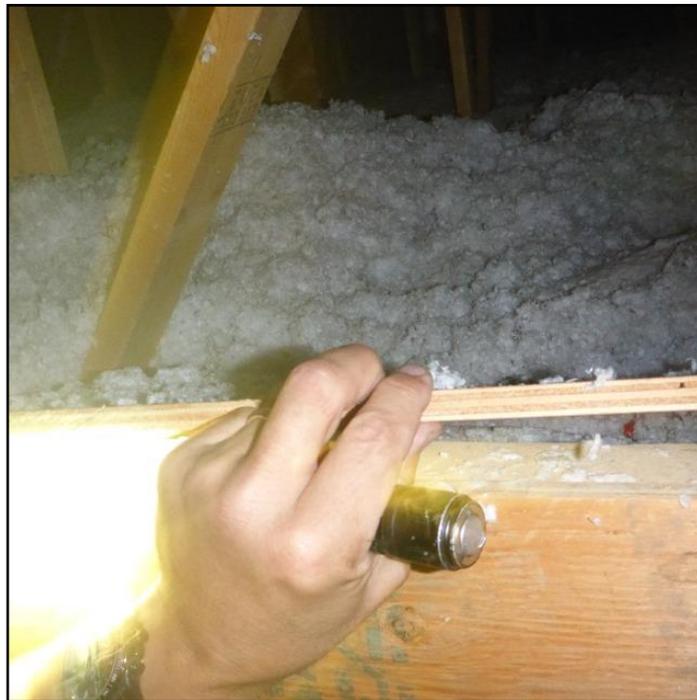
Condition: • Access hatch insulation/weatherstripping/fit less than ideal

Missing insulation

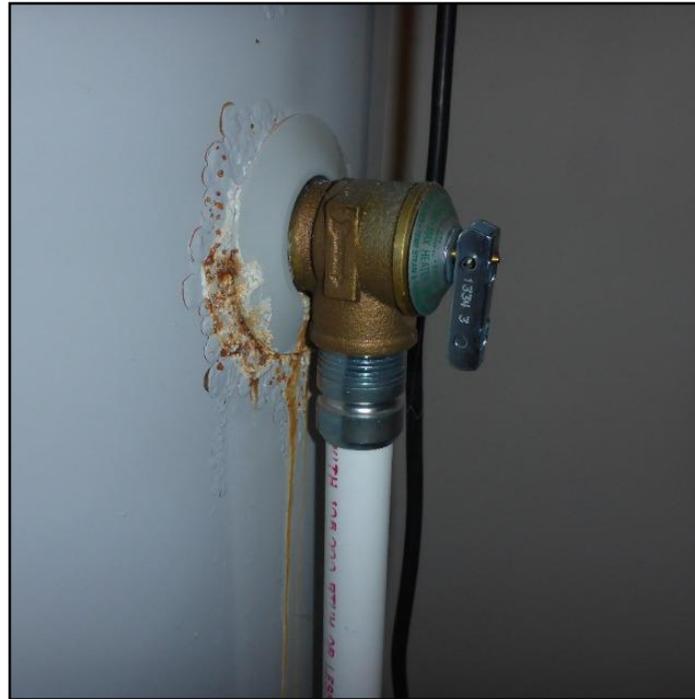
Condition: • [Near end of normal life expectancy](#)

Corroded water heater

Task: Replace

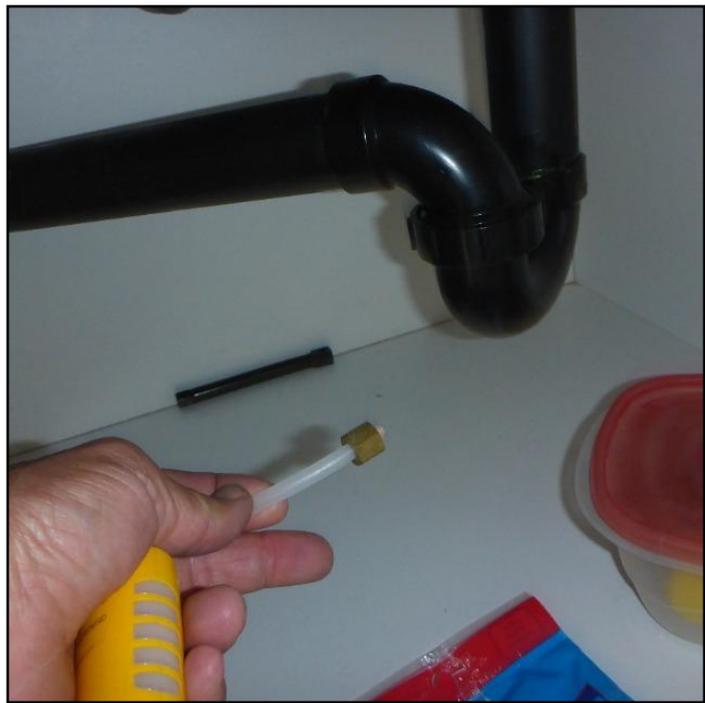
Condition: • Trap primer missing/disconnected

Disconnected at laundry room

This is not likely to cause problems. If concerned, hook the trap primer back up or pour mineral oil down the floor drains (won't evaporate and environmentally friendly).

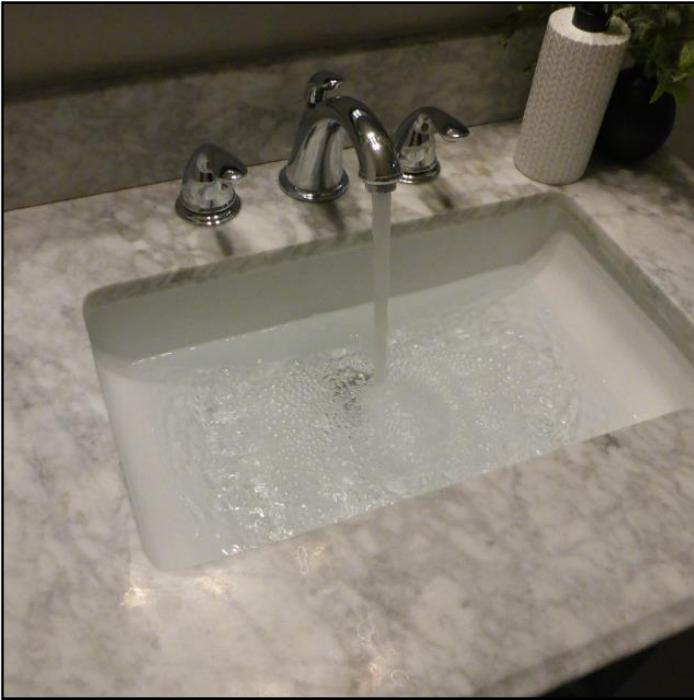
Condition: • [Drain slow](#)

Slow drain in basement

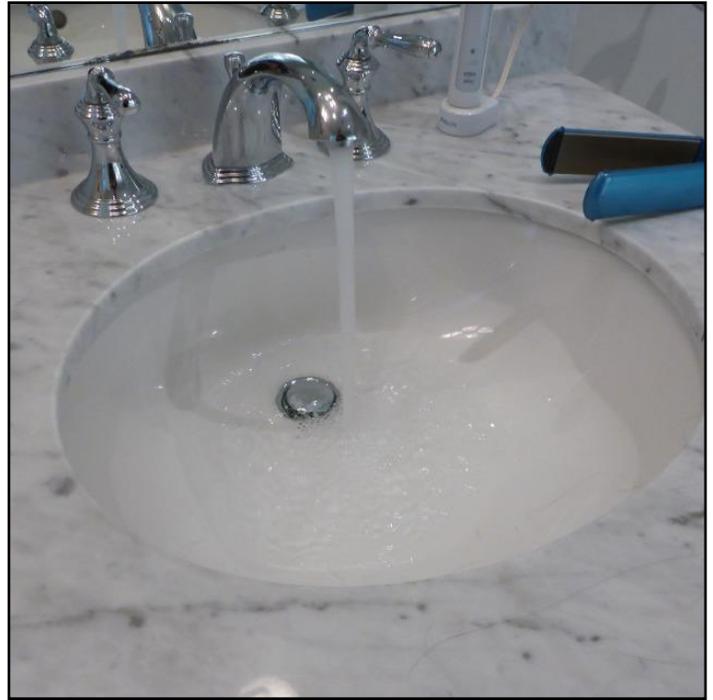
Slow drain at primary ensuite

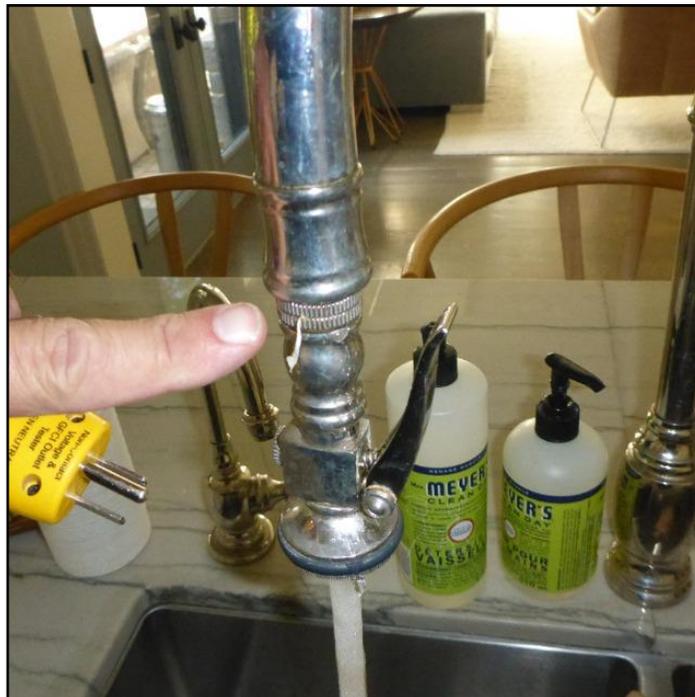
Condition: • [Leak](#)

Leak at kitchen

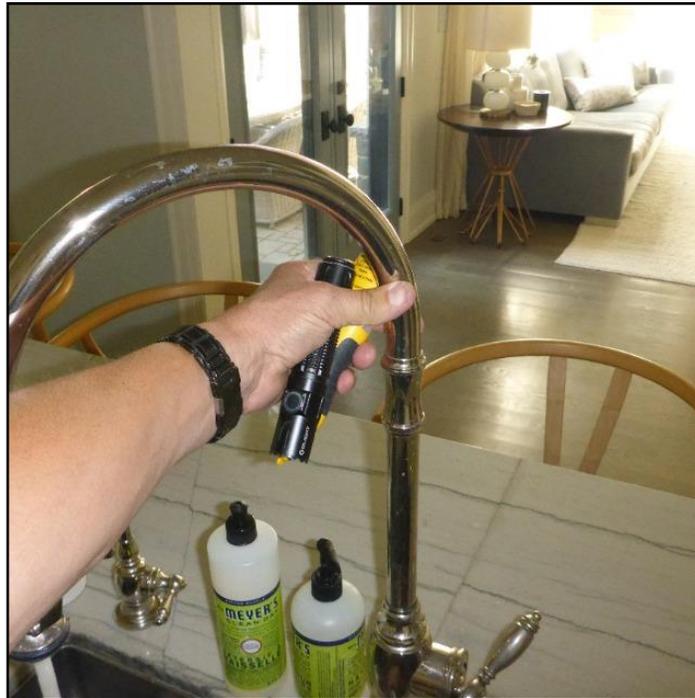
Condition: • [Loose](#)

Loose at kitchen

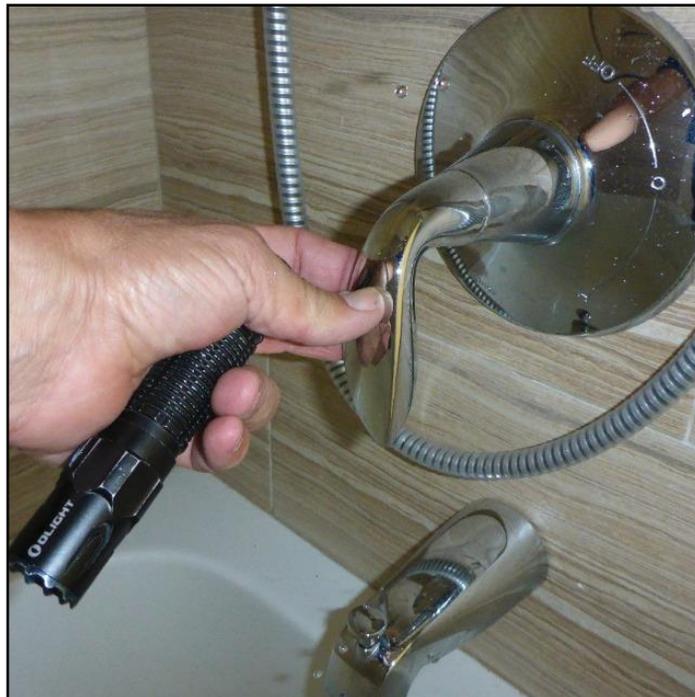
Condition: • Loose handle noted

Loose handle at tub

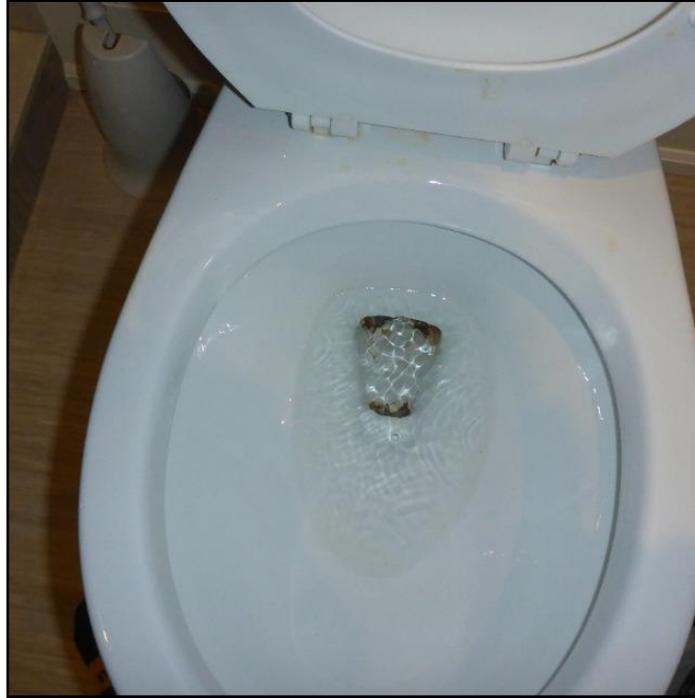
Condition: • Stains noted at toilet bowl. These are often permanent.

Stained toilets

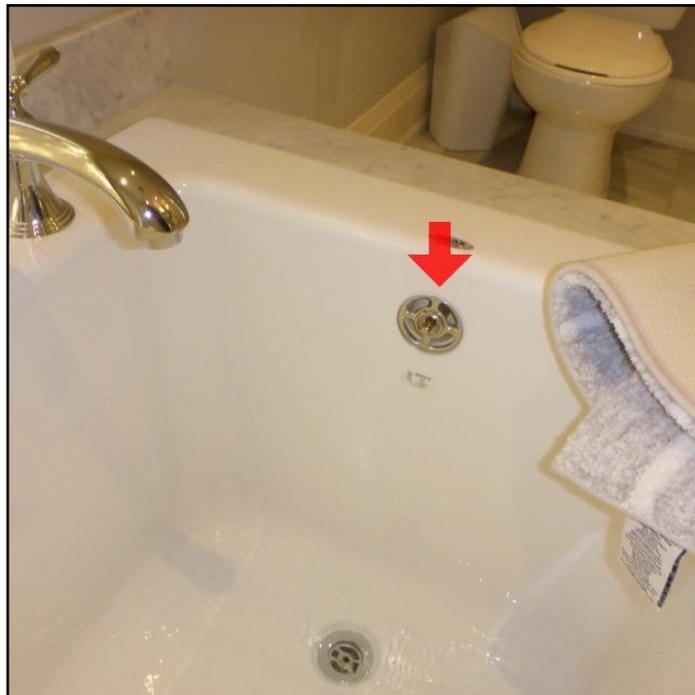
Condition: • Overflow cover is missing

Missing cover in primary ensuite

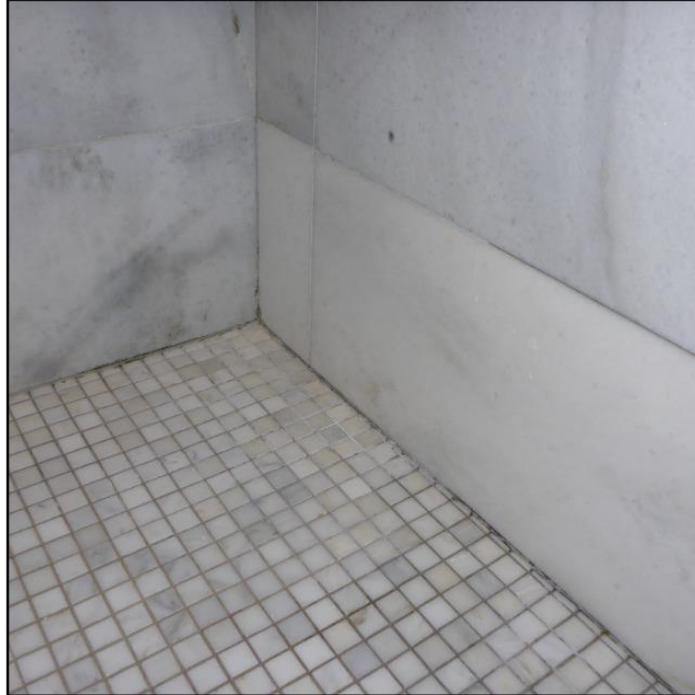
Condition: • Caulking and grout should be checked every six months and improved as necessary to prevent leakage and damage behind wall surfaces.

Shower stall maintenance required

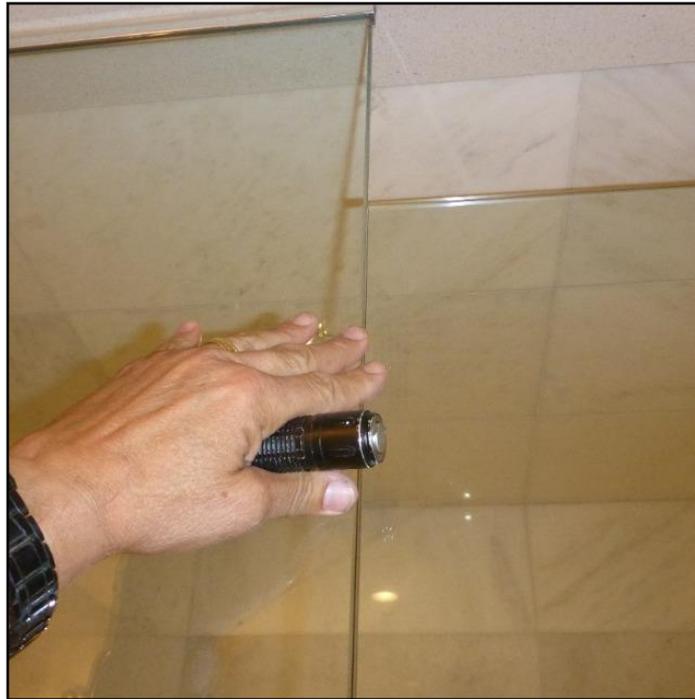
Condition: • [Door - adjustment needed](#)

Location: Basement bathroom

Door hits at top

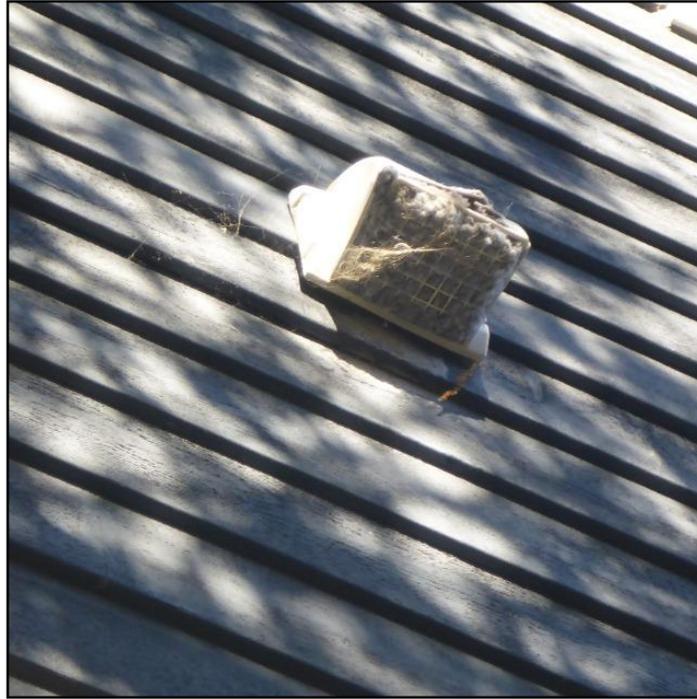
Condition: • Plugged dryer vent noted

Plugged dryer vent

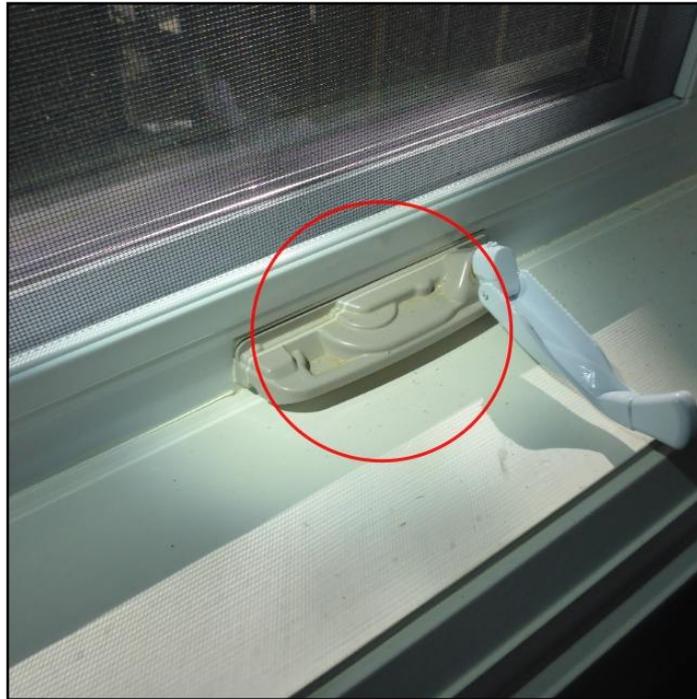
Condition: • [Hardware missing or defective](#)

Missing cover in dining room

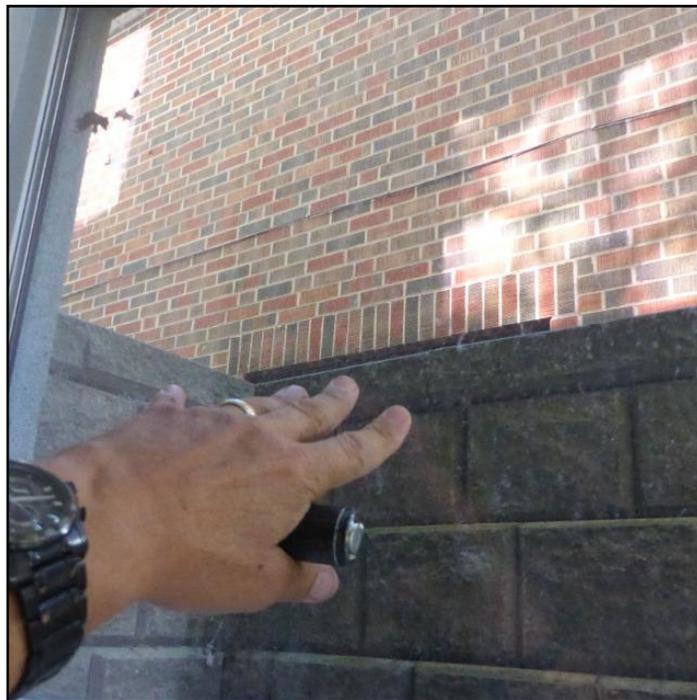
Condition: • [Screen missing](#)

Missing screens in basement

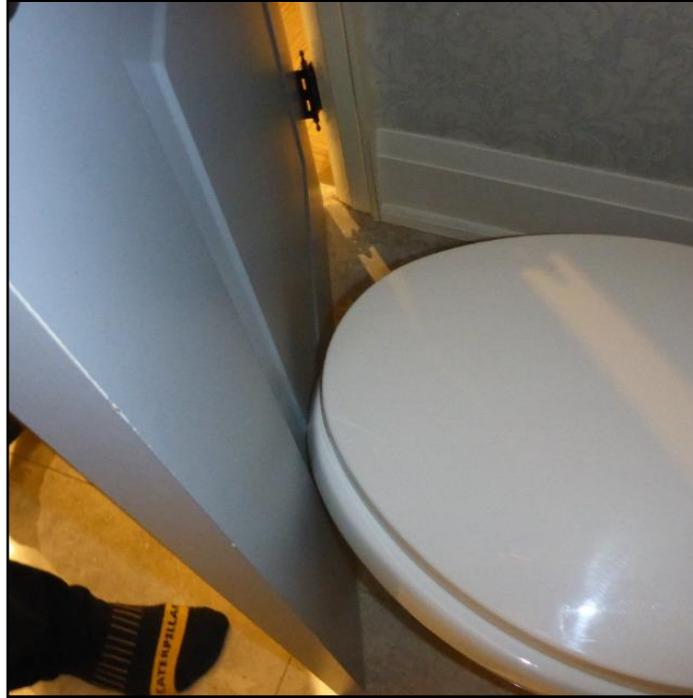
Condition: • Missing door stops noted.

Missing door stop in powder room
