15 Katrina Court, Toronto, Ontario

SUMMARY INSPECTION REPORT

INSPECTION REPORT

PROPERTY: 15 Katrina Court, Toronto, Ontario

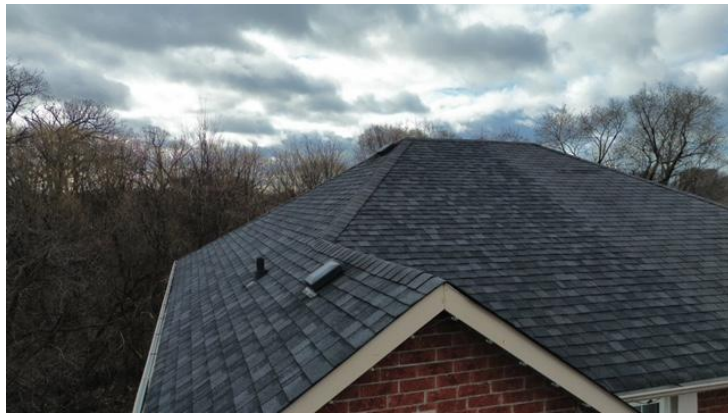
2.03A Asphalt roofing shingles: Typically, this type of roofing material will last 20 years. All flashing around roof projections should be checked periodically to ensure there is a watertight seal.

Slopes that face south and west receive more sunlight and generally wear faster. The asphalt shingles were inspected using a drone and are in good condition. They were upgraded 10-15 years ago and show minimal wear. No water stains were observed on the plywood sheathing below the roof shingles as viewed from the attic hatch.
