National Home Inspection Ltd.  
2255B Queen Street East, Unit 1160,  
Toronto, Ontario  
M4E 1G3  
TEL: (416) 467-7809

36 Clockwork Lane, Toronto, Ontario

## **SUMMARY INSPECTION REPORT**

## INSPECTION REPORT

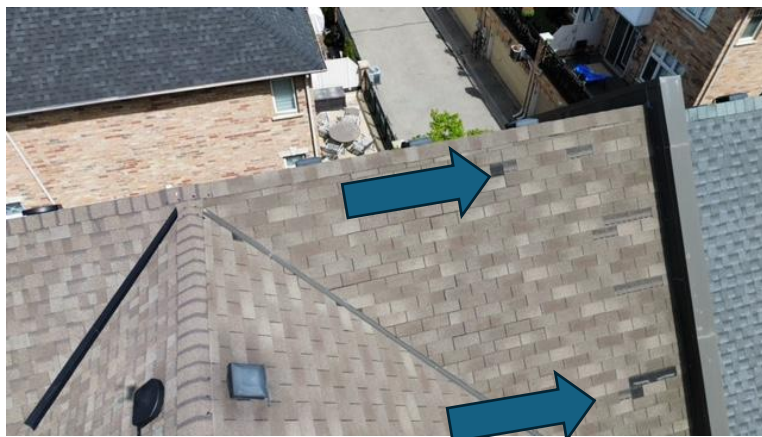
2.03A Asphalt roofing shingles: Typically, this type of roofing material will last 20 years. All flashing around roof projections should be checked periodically to ensure there is a watertight seal. Slopes that face south and west receive more sunlight and generally wear faster. The asphalt shingles were inspected using a drone and are in acceptable condition. There is one layer of asphalt shingles present on all sides.

*P: replace missing shingles (3-4) on the south side.*
